Accelerated Precast Bridge Approach Slab Replacement

ABSTRACT

Bremer Co (Design 208)

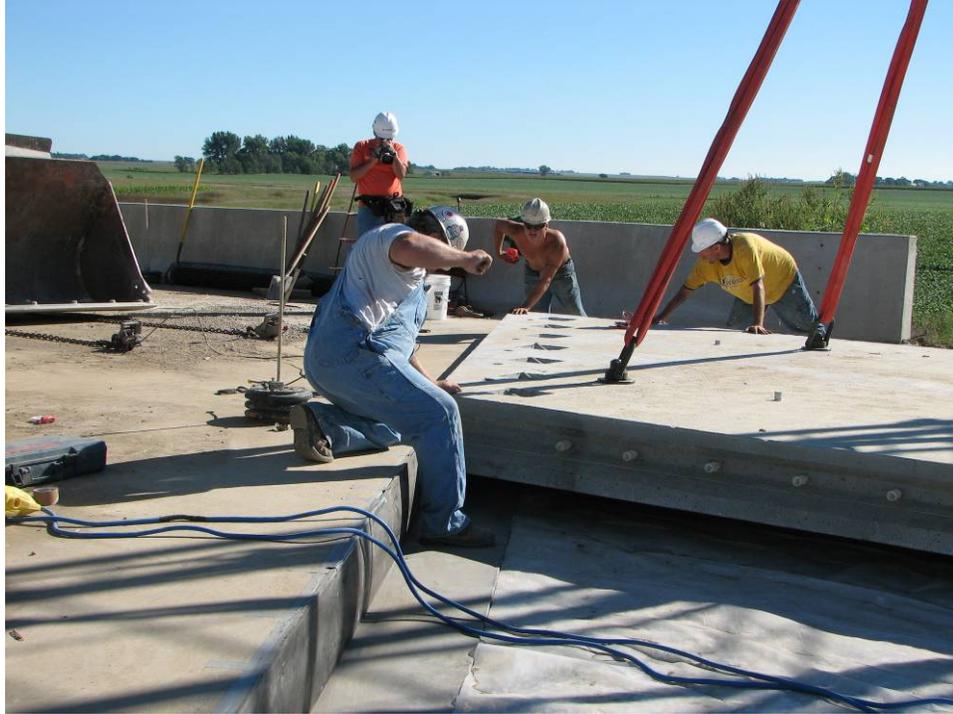
Figure No. 2
(Placement of First Panel at Abutment)

Located in O'Brien County in northwest Iowa on IA 60, the precast approaches were only used on the north bound lanes. The panels were attached directly to the integral abutments of the prestressed concrete bridge. See Figure 1. Eight 12 inch panels were placed at each end for a total length of 76 feet 11 inches measured along centerline. The panels next to the abutment were skewed 30 degrees to match the bridge abutments and the remaining panels were 14 ft x 20 ft. Once placed the approaches were post-tensioned both transversely and longitudinally using 0.6 inch diameter strands spaced at approximately 24 inches. See Figure 1, 2 and 3 for a details and photos of the project.

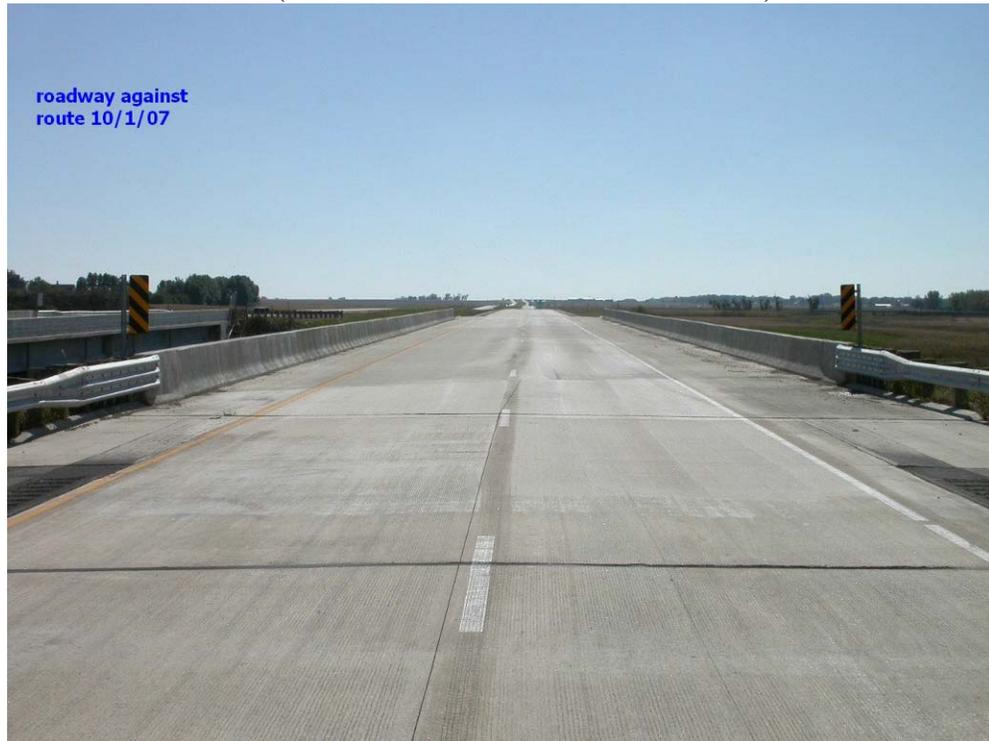
Figure No. 3
(Completed Approach)

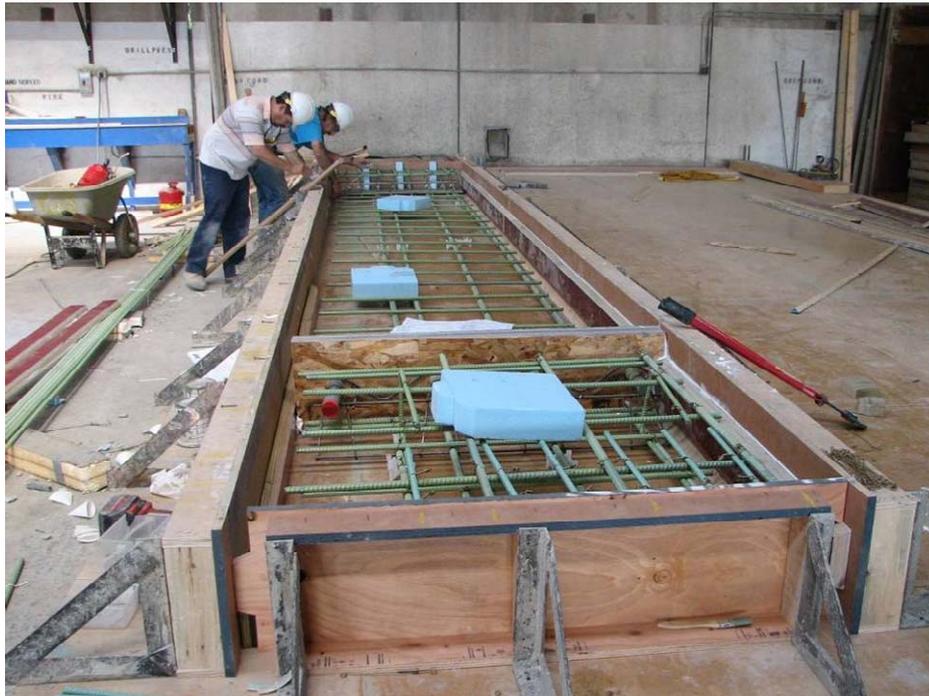
Figure 11
(Forming of shoulder panel)

Figure 11 shows preparation for the casting of a shoulder panel and Figure 12 a completed 12 ft roadway panel in the casting yard. Temporary shipping angles were attached to the top of the panels over the expansion joint to prevent movement during handling.

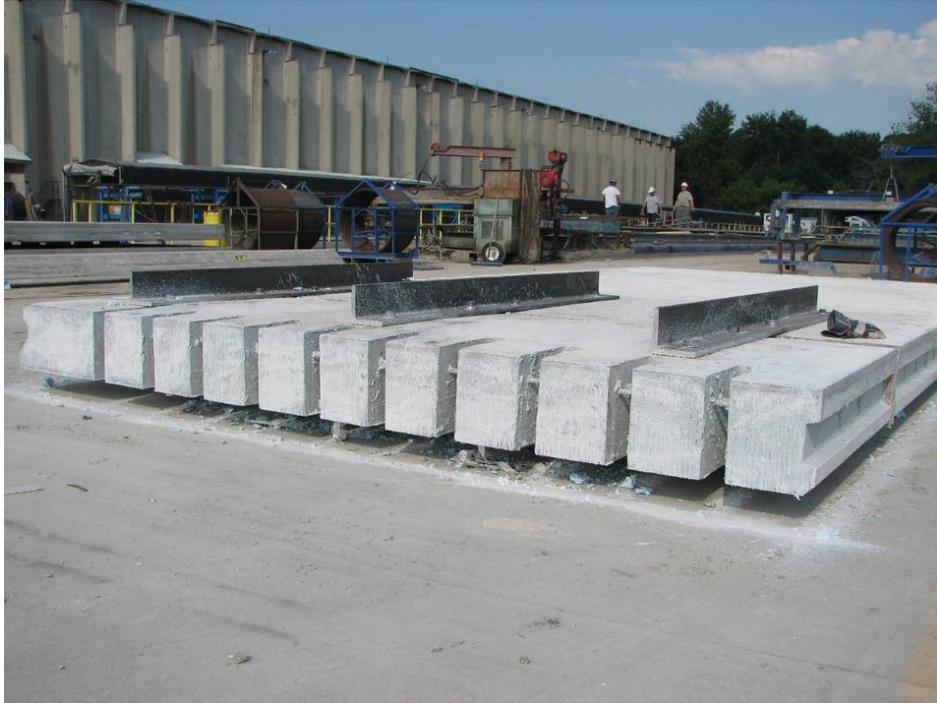
Figure 12
(12 ft Roadway panel in precasting yard)

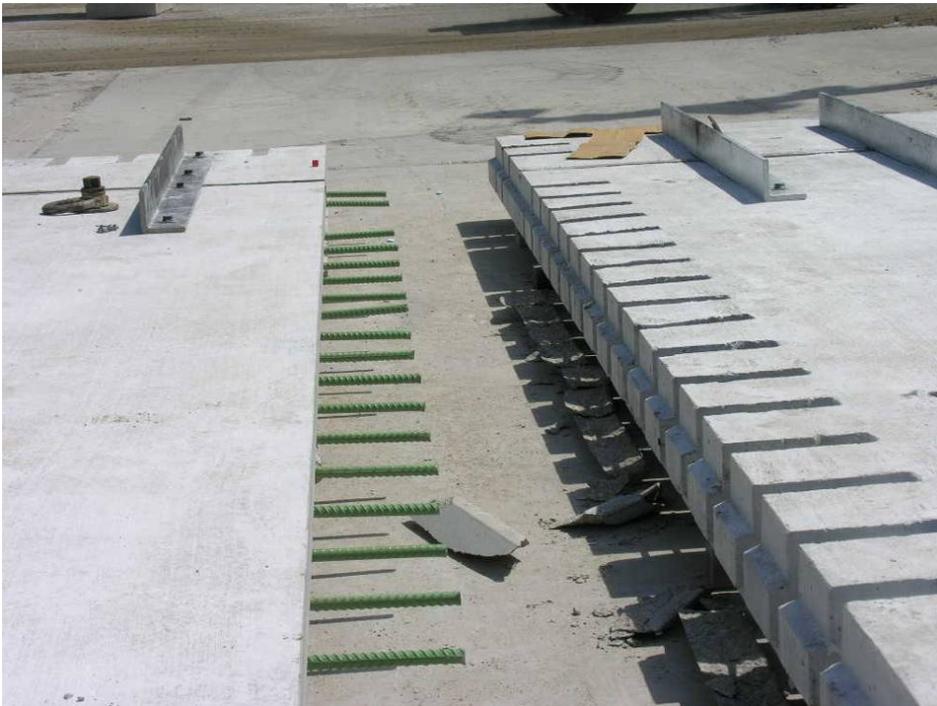
Figure 13
(Connection at shoulder line)

Figure 13 shows the roadway section with the 1 in. diameter dowel in place next to the 7'-11 shoulder section before the fit up test. Figure 14 is a side view of the panels during the fit up of the shoulder keyway and Figure 15 a plan view of the pocket locations at the joint.

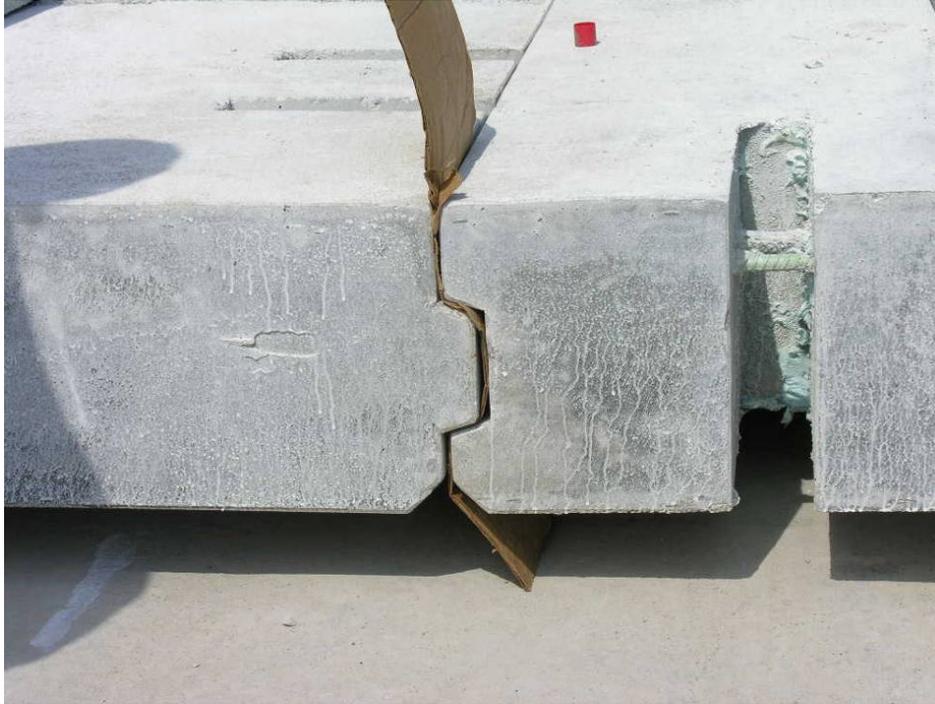
Figure 14
(Fit-up test at shoulder line keyway)

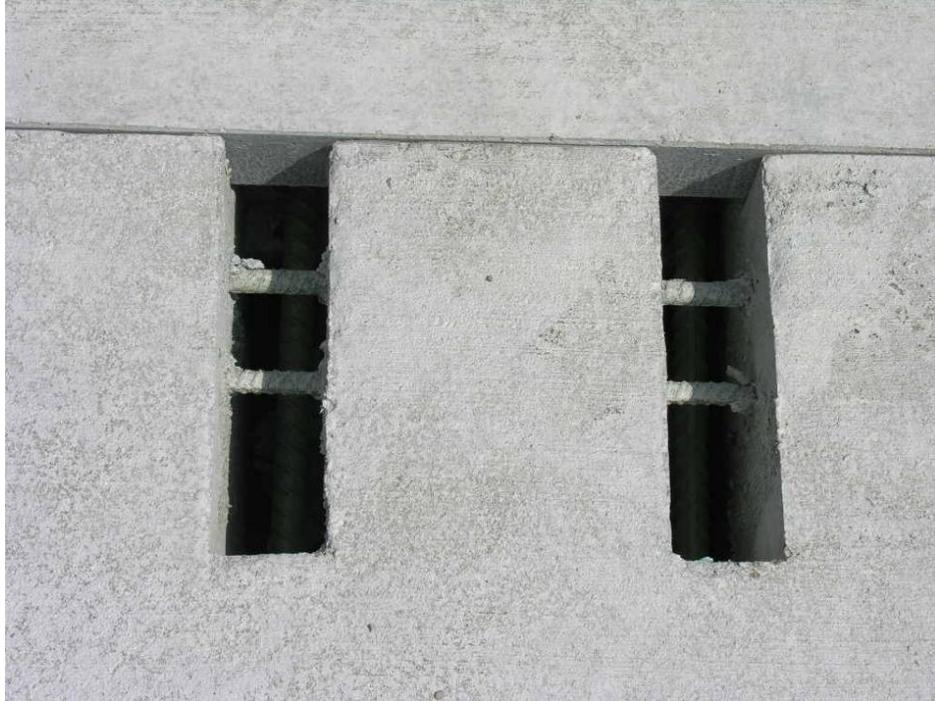
Figure 15
(Fit-up test at shoulder line showing pockets)

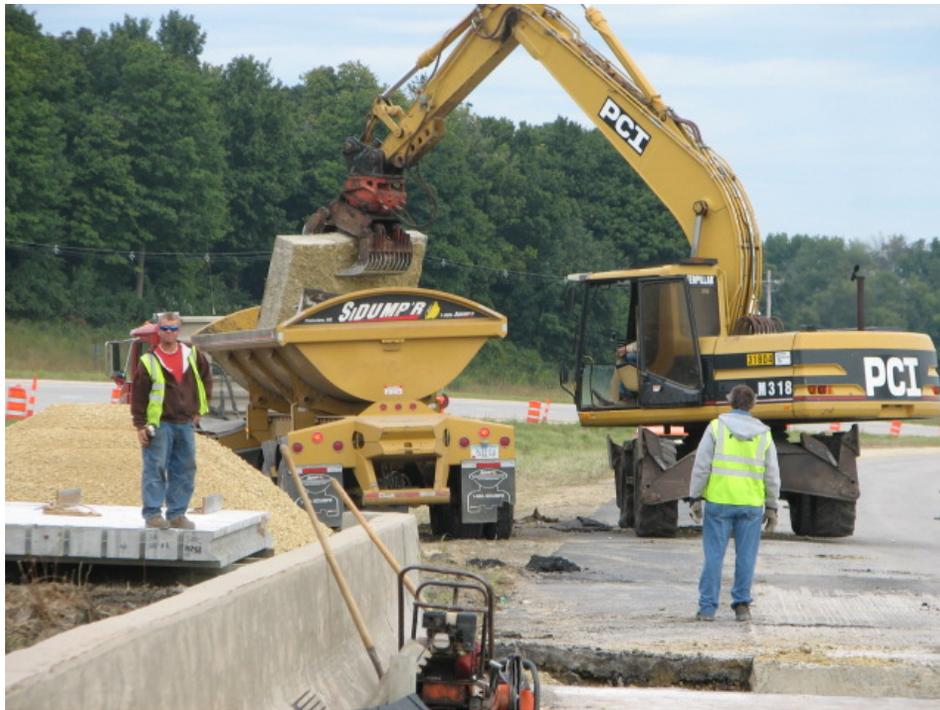
Figure 16
(Construction removing existing approach)

The next series of photos (Figures 16 through 27) are the construction sequence of the project. The existing approach slab was removed in sections as shown Figure 16. The approach had been sawcut into the smaller sections before the 11 hour lane closure started. After removal, the paving notch was cleaned and inspected to make sure an adequate bearing width (minimum 5 inches) was available to support the panels. The existing base course was cleaned of debris and leveled with additional granular backfill and then finished to the required grade with a 2 inch sand leveling course (Figures 17 and 18).

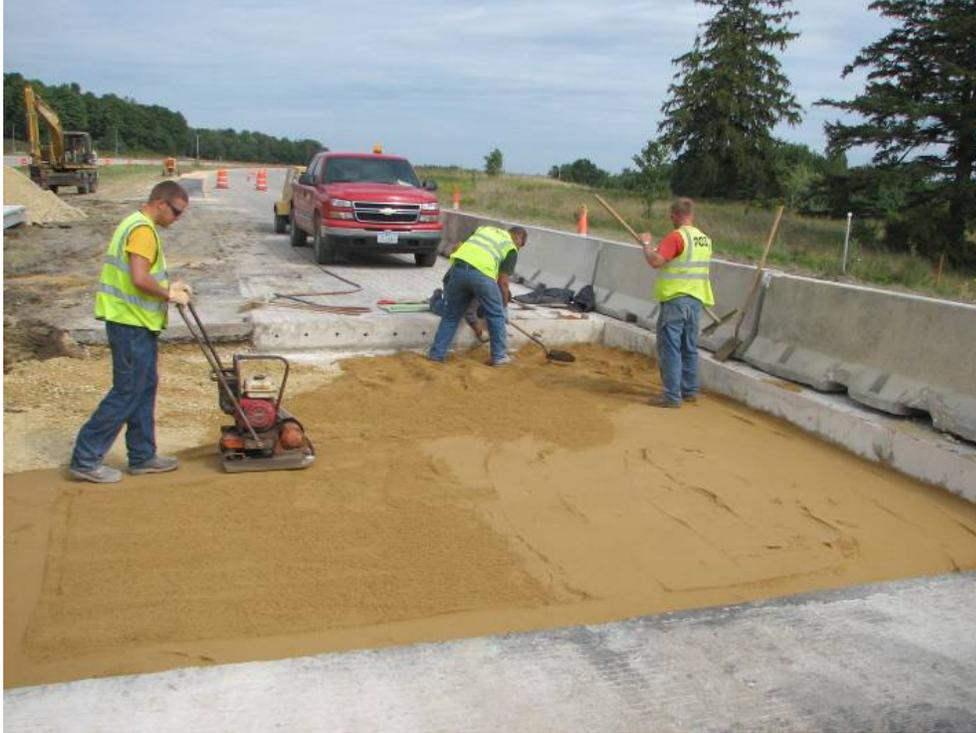
Figure 18
(Sand leveling surface preparation)

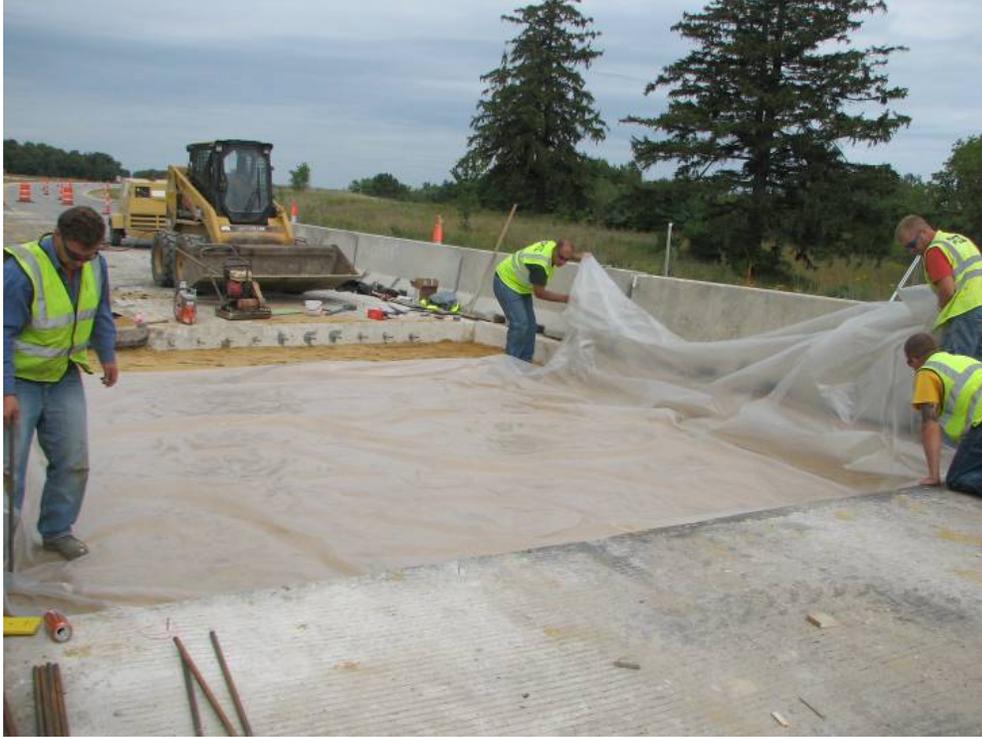
Figure 19
(Installation plastic sheeting)

Four mil polyethylene sheeting was added as a bond breaker to allow the panels to move with temperature changes (Figure 19), and the precast panels were placed. The first 12 ft roadway panel and 3'-10 shoulder panel were placed with a crane (Figure 20 and 21).

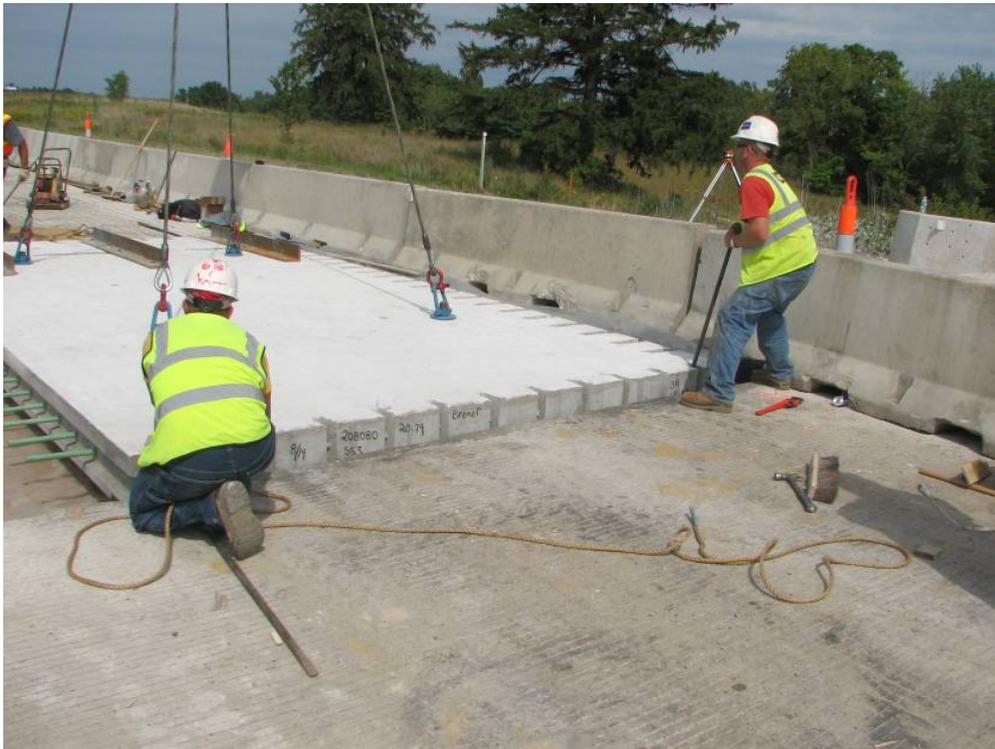
Figure 20
(Installation of first roadway panel)

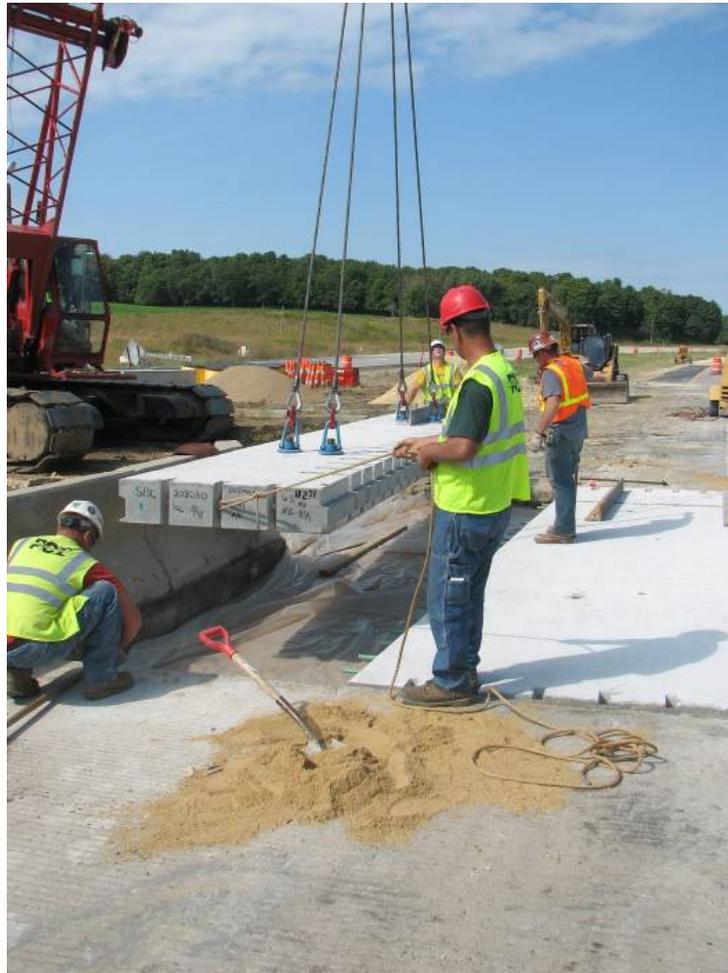
Figure 21
(Installation of inside 3'-10 shoulder panel)

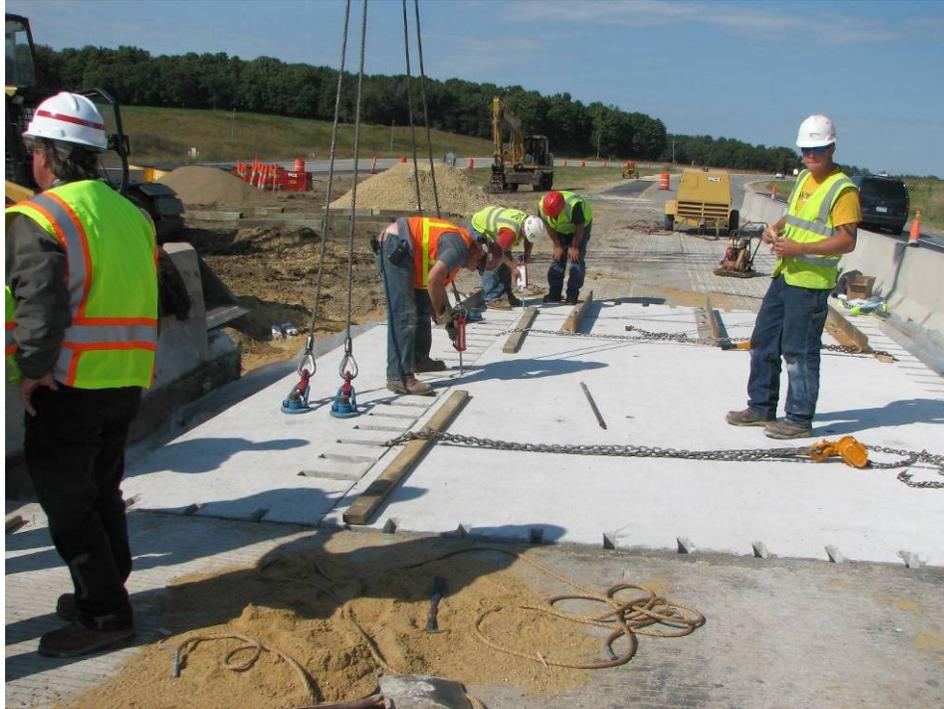
Figure 22
(Providing epoxy for keyway at shoulder line)

The shoulder joint was tied together using an epoxy compound in the keyway and the 1 in diameter mechanical bar splicer's, grouted in the 3 in x 12 inch pockets (Figure 22). A temporary cold mix was used between the precast panel and existing pavement at the centerline of the roadway (Figure 23).

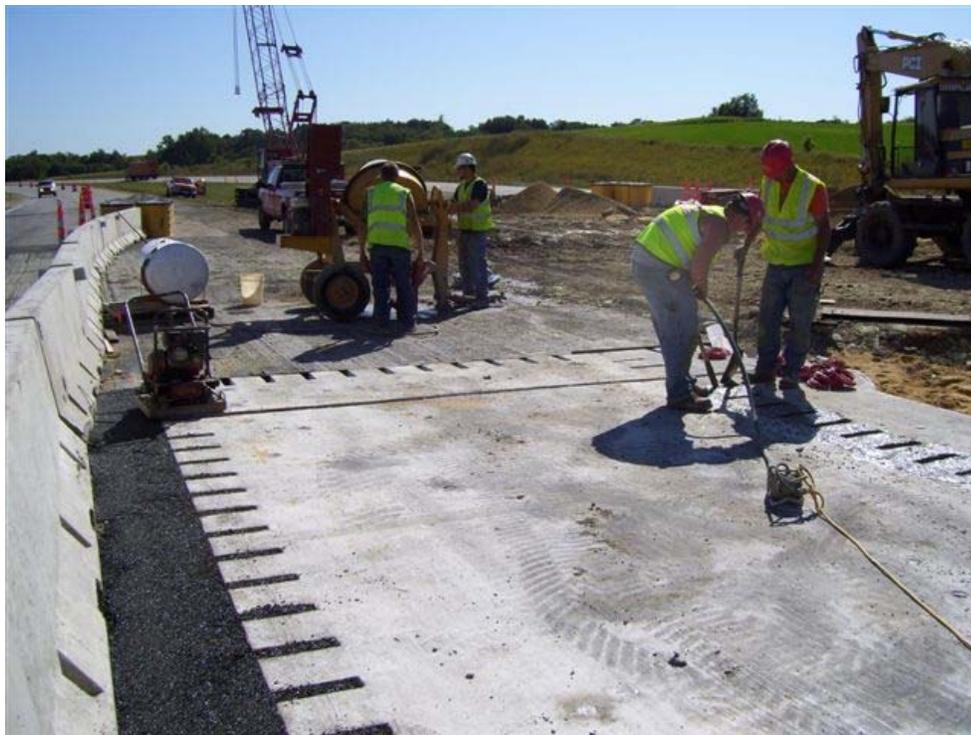
Figure 23
(Grouting pockets and temporary joint at centerline)

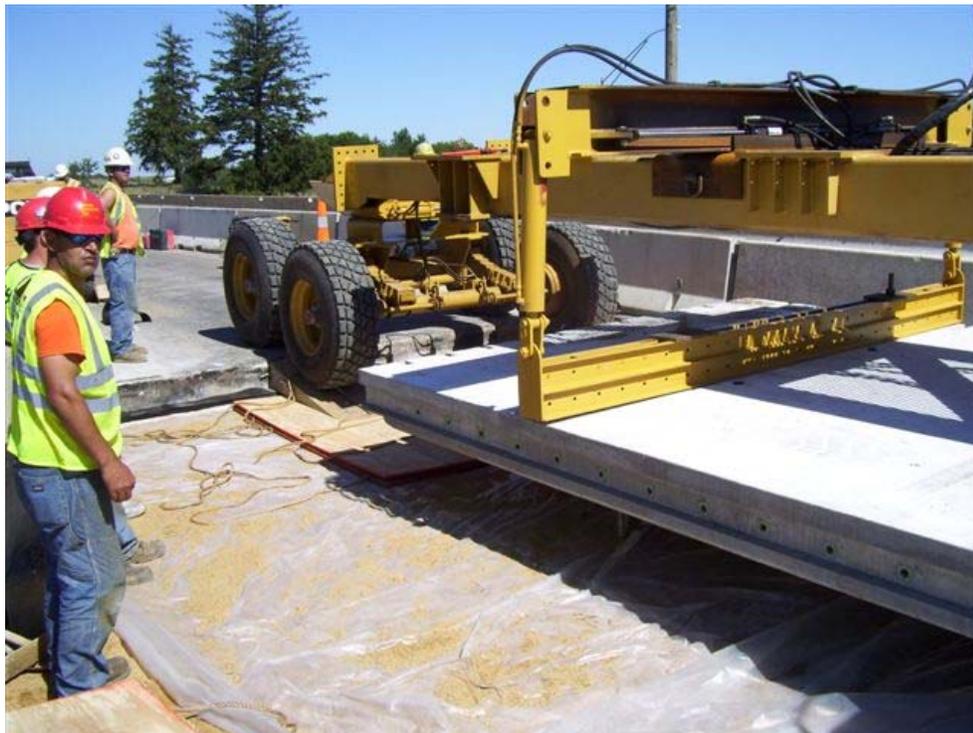
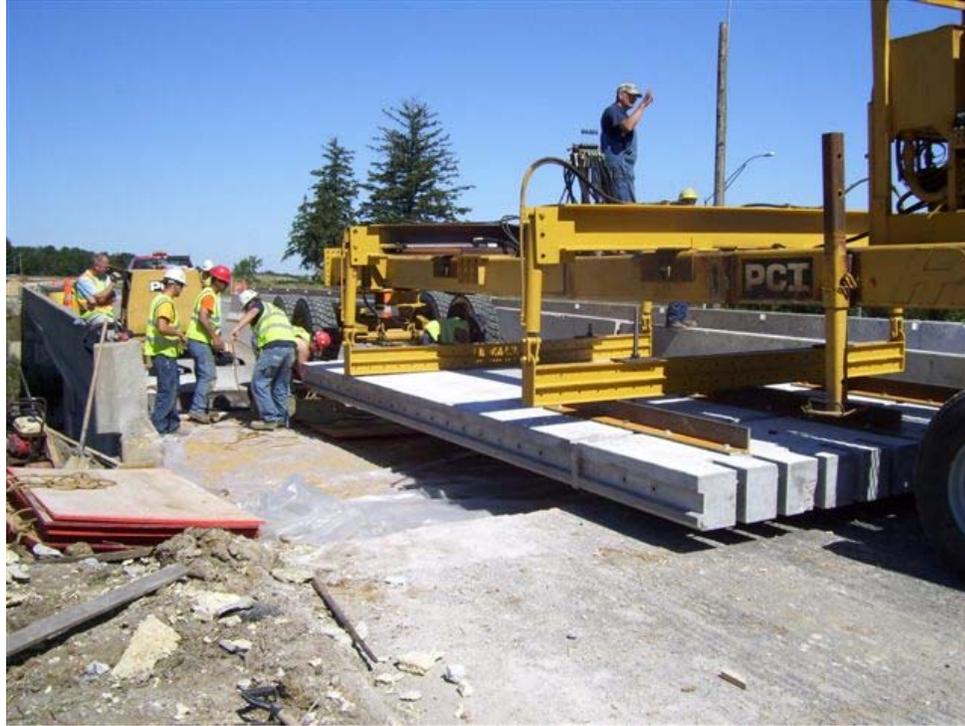
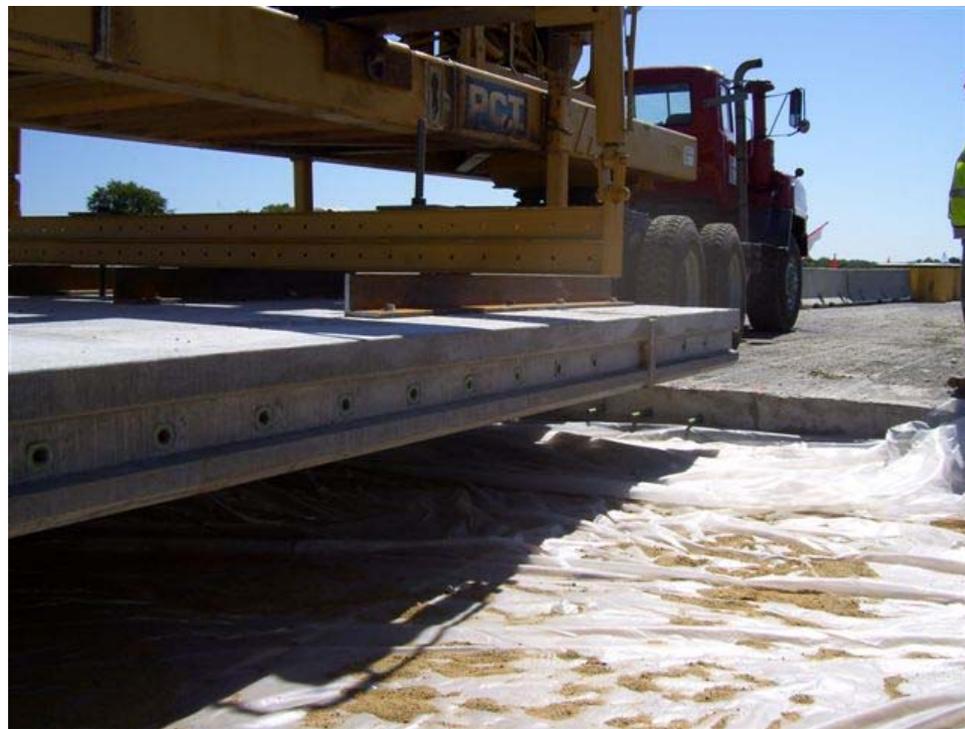
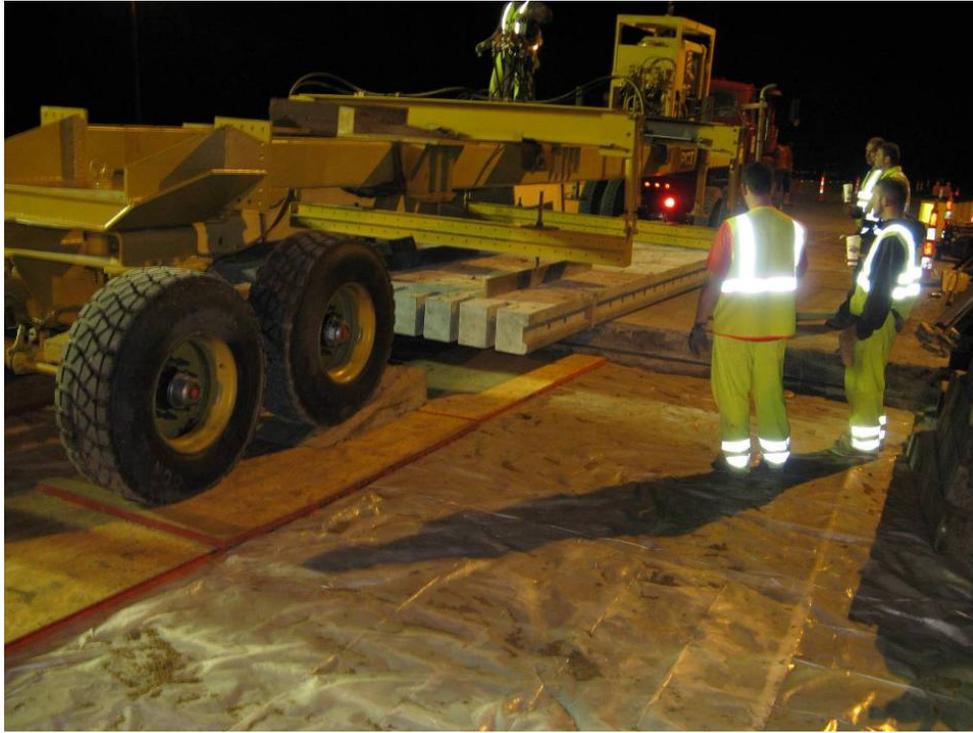
Figure 24
(Installation of panel using trailer transport)

Figure 25
(Installation of panel using trailer transport)

Figure 26
(Installation of panel using trailer transport)

Figure 27
(Night installation using trailer transport system)

Because of issues with temporary roadway closure and movement of the crane over existing pavement, the contractor also developed and used a trailer for placing the precast panels. This trailer used a hydraulic system for making horizontal adjustments of the panel before lowering it into place. See figures 24 through 27. Wood ramps and plywood were used to allow the trailer wheels to move across the backfill area (Figure 24). The controls for the panel adjustment were located on the top of the trailer (Figure 25) to give the operator a better view of the panel placement. This system was used successfully for both daytime and nighttime placement.

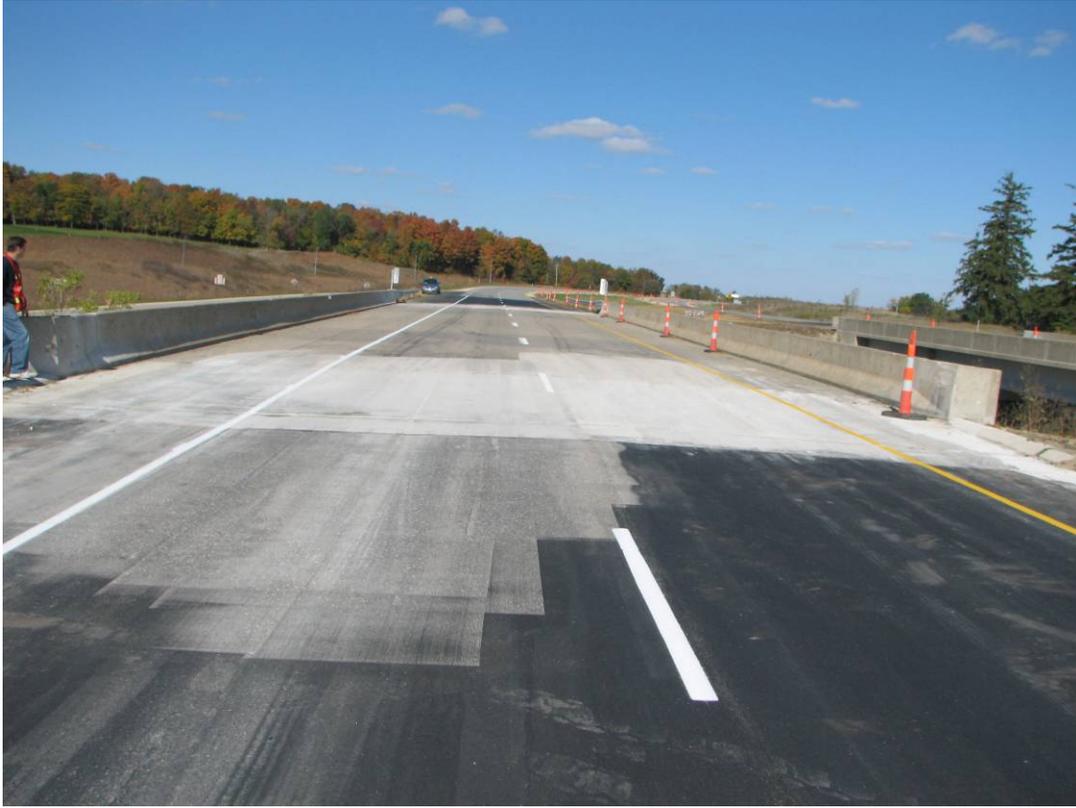
Figure 28
(Completed approaches-SBL looking North)

Once the panels were in place a asphalt transition wedge was place between the existing pavement and new precast panels. This was then longitudinally ground to a smooth transition and also to provide texture in the precast panels.
