## **INSTRUMENTATION AND MONITORING OF IN-SITU PRECAST CONCRETE APPROACH SLAB SYSTEM WITH NOVEL JOINT DETAIL**

**Mohamed K. ElBatanouny, PhD**, Wiss, Janney, Elstner Associates, Inc., Northbrook, IL  
**Matthew Jones**, Staff Structural Engineer, Primus Design Services LLC, Woodstock, GA  
**Paul H. Ziehl, PhD, PE**, Dept. of Civil and Environ. Engineering,  
University of South Carolina, Columbia, SC

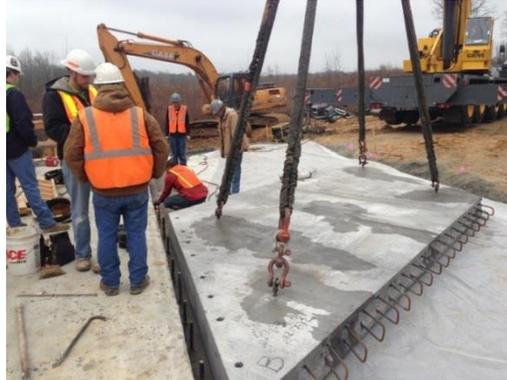
Fig. 2 Interior approach slab being set with vertical dowel alignment

The bridge side edge of each approach slab is seated on a ledger formed into the cast-in-place bridge deck. A photograph of the ledger is shown in Figure 2. Vertical dowel bars are embedded into the cast-in-place ledger and each approach slab has corresponding vertical sleeves embedded near the bridge side edge of the slab. These sleeves are located such that full alignment with the dowels is achieved. Alignment of reinforcing dowels is shown in Figure 2 for the placement of an interior slab on the bridge approach. Dowel sleeves were filled with grout after the approach slabs were set in place.

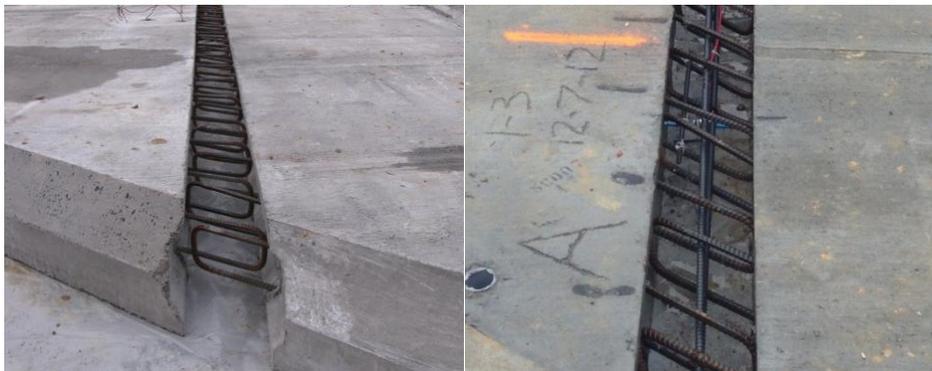
Fig. 3 Interlocking of loop bars after slab placement and (left); shear key connection joint with longitudinal reinforcing bars (right)

The precast concrete approach slabs utilized a connection joint detail consisting of interlocking looped (U-bar) reinforcement oriented transversely, relative to the joint, along with a female-to-female shear key as well as two longitudinal reinforcing bars. The purpose of the shear keys is to provide resistance to moving traffic loads by facilitating the transfer of shear forces between adjacent slabs. Shear keys allow the system of discrete panels to react monolithically (as a single piece of reinforced concrete) under applied loadings. The U-bars are spliced with the transverse reinforcement within the precast panel and are 0.625 inches in diameter (No. 5). The two longitudinal reinforcing bars are 0.75 inches in diameter (No. 6), located in the middle of the joint, threaded through the inside of the loop bars, and are tied in at the top and bottom. The loop bars have an even spacing where each panel is out of phase with the adjacent panel by a half space. Photographs showing the interlocking of reinforcement between adjacent slabs and longitudinal reinforcement are shown in Figure 3. The connection joint is intended to transfer and distribute shear and moment between adjacent panels, thereby enhancing strength of the approach slab system while exhibiting satisfactory crack resistance. After the precast concrete approach slabs were set in place, longitudinal bars were tied to the top and bottom loop bars and the shear keys were filled with concrete.

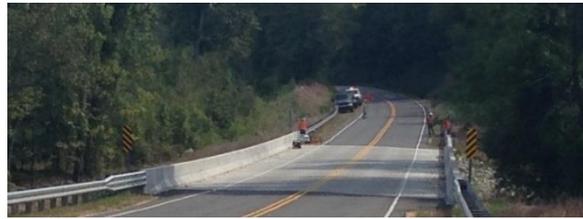
Fig. 4 Replacement bridge over Big Brown Creek

After the bridge parapets were placed each approach was covered with asphalt pavement. The asphalt surfacing is 2.5 inches thick and extends up to the cast-in-place bridge deck. Figure 4 shows the bridge after construction was completed.

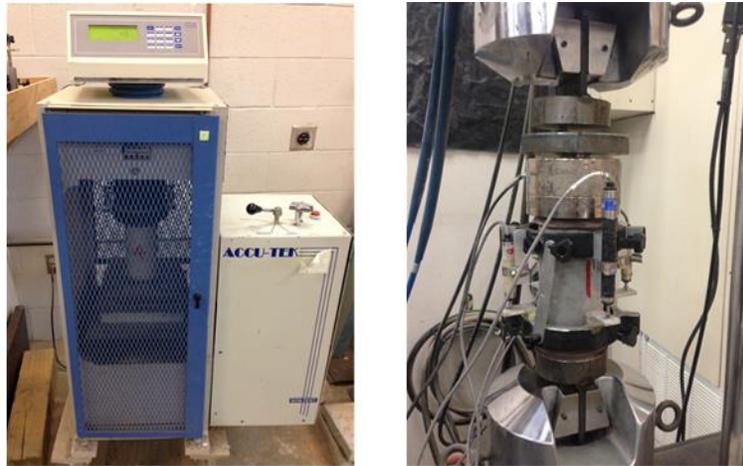
Fig. 7 Compressive strength testing (left); modulus of elasticity testing (right)

of concrete to provide three specimens for testing compressive strength at 7, 14, 28, and 56 days and 3 specimens for modulus of elasticity testing at 56 days. The approach slab system required several separate batches of concrete: Batch 1 for the casting of approach slab 'B', Batch 2 for the casting of approach slab 'C', Batch 3 for casting of approach slabs 'A' and 'D', and Batch 4 for the shear key closures. Slump tests were also performed on each batch of concrete. Figure 7 shows concrete compression testing in progress and the modulus of elasticity test setup.

Concrete compressive strength testing was performed in general conformance with ASTM C39 / C39M- 12a<sup>4</sup>; modulus of elasticity testing was performed in general conformance with ASTM C469/C469M<sup>5</sup>; and sampling of concrete and slump testing were performed in general conformance with ASTM C31- 12<sup>6</sup> and ASTM C143- 12<sup>7</sup>.

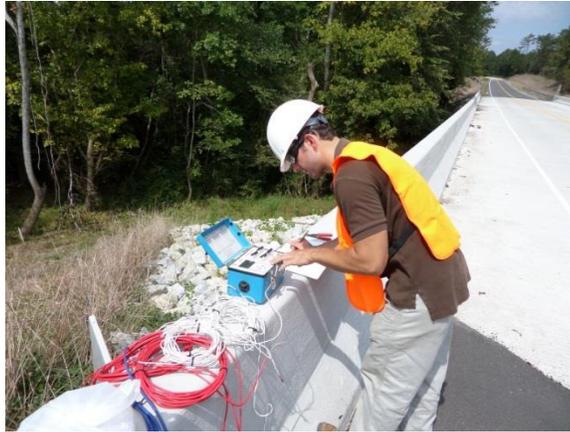
Fig. 8 Strain readings recorded with Vishay P3 strain indicator

Discrete readings from VWSGs, VWDGs, and ERSGs were recorded on-site in accordance with the data acquisition schedule. Strain and displacement measurements shown are relative to the initial readings. For VWSGs and ERSGs the initial reading is considered as the reading taken when instruments were tied securely into reinforcing cages just prior to concrete placement. For VWDGs the initial reading was recorded just after the installation of the gages on the outside of the bridge parapets. Vibrating wire based readings have been corrected for effects due to temperature variation and electrical resistance based sensors are corrected for the effect of cable gage length. Photos showing collection of data for VWSGs and ERSGs are shown in Figure 8.

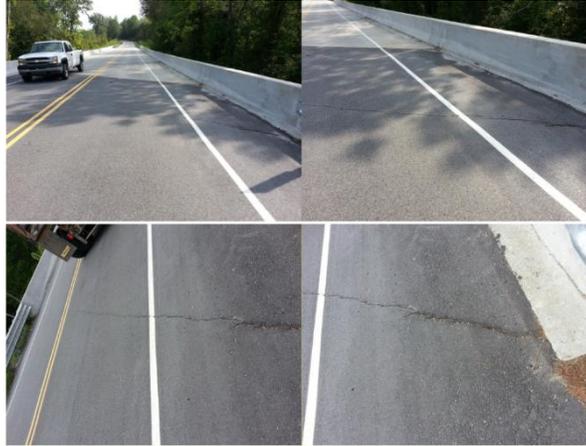
Fig.17 Photographs of observed cracks at approach slab/roadway interface  
(Upper, approach to Bent Four looking south; lower, approach to Bent One looking north)

During the last load test, cracks at the interface of the approach slabs and the roadway were observed at both Bents (Figure 17). These cracks were most severe on the side of the bridge associated with vibrating wire displacement gages 1 and 4. In the case of VWDG 3 the largest extension was recorded (0.13 in. relative to the reading taken just after bridge construction) in combination with very small contraction at VWDG 4 (0.05 in. relative to the same point in time). This pattern is consistent with the observed cracking assuming that rotation of the approach slab was a contributing factor. In the case of VWDG 1, a relatively small value of contraction was recorded (0.02 in. relative to the same point in time) in combination with 0.03 in. extension at VWDG 2 (relative to the same point in time). This pattern is again consistent with rotation that may lead to cracking, but the relative values are very small. It does not therefore appear that rotation of the approach slabs is the primary cause of the observed

cracking. It is possible that differential settlement between the approach slab and the roadway has contributed to the cracking, perhaps in combination with temperature effects related to the roadway asphalt. No cracks were observed at the approach slab/bridge interface indicating that differential settlement between the approach slabs and the bridge is minimal.
