# Evaluation of Keyway Grout Test Methods for Precast Concrete Bridges\*

by Robert J. Gulyas, Gregory J. Wirthlin and Jeffrey T. Champa

Comments by Dennis Nottingham and Authors

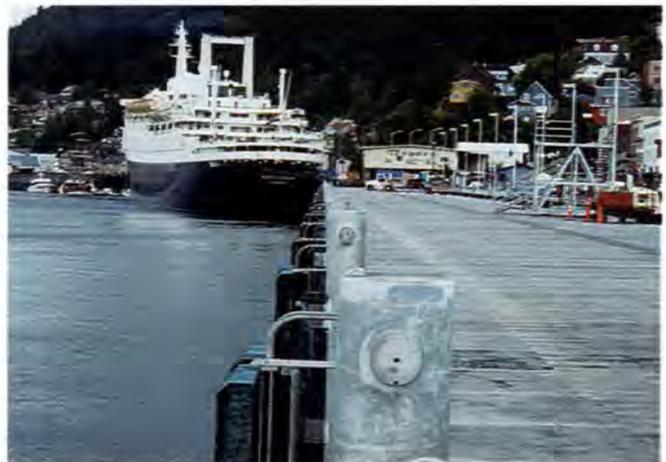
Fig. A. Typical precast, prestressed concrete grouted dock deck, Ketchikan, Alaska.

struction use grouted precast concrete deck panels, as evidenced by the recently completed 1450 ft (442 m) Ketchikan Tourship Dock (see Fig. A). Precast, prestressed concrete deck panels composite with steel box girders allowed this project to be designed and built in only 8 months. Prestressing was also applied to supporting steel pipe pile rock anchors grouted into bedrock as a means of resisting severe ship and seismic forces.

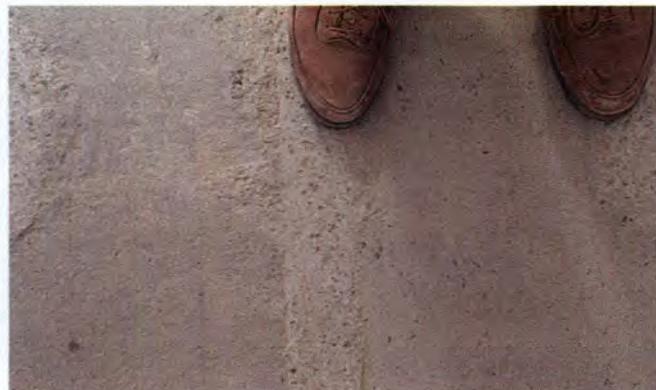
Fig. F. Set 45 extended magnesium ammonium phosphate grout joint.

Fig. F shows the results of properly applying such a grout, sold commercially as Set 45. Note that both pockets and joints show complete bond after 2 years in this heavily used arctic bridge.

These elevated temperatures and lower humidity levels would likely be encountered by any keyway grouting material. Perhaps this comparative performance is what accounts for the differences noted in Mr. Nottingham's Figs. E and F
