Loadbearing Architectural Precast Panels Provide Solution for Performing Arts Center Theater Expansion

A \$32 million renovation and expansion of the Times-Union Performing Arts Center in Jacksonville, Florida, was made possible by using loadbearing architectural precast concrete panels for the interior walls of the new theater addition. The massive panels were cast with flat exterior sides and curving, smooth interior faces to act as the acoustical walls for the theater. Erecting the huge panels required a two-stage lift involving two cranes positioned inside the theater. Another key aspect of the project came in adding two post-tensioned concrete balconies. The solid slabs were cantilevered over the ground-floor seating and supported from the precast concrete rear wall of the theater. The use of precast components saved time and labor costs and helped keep the fast-track project on schedule.

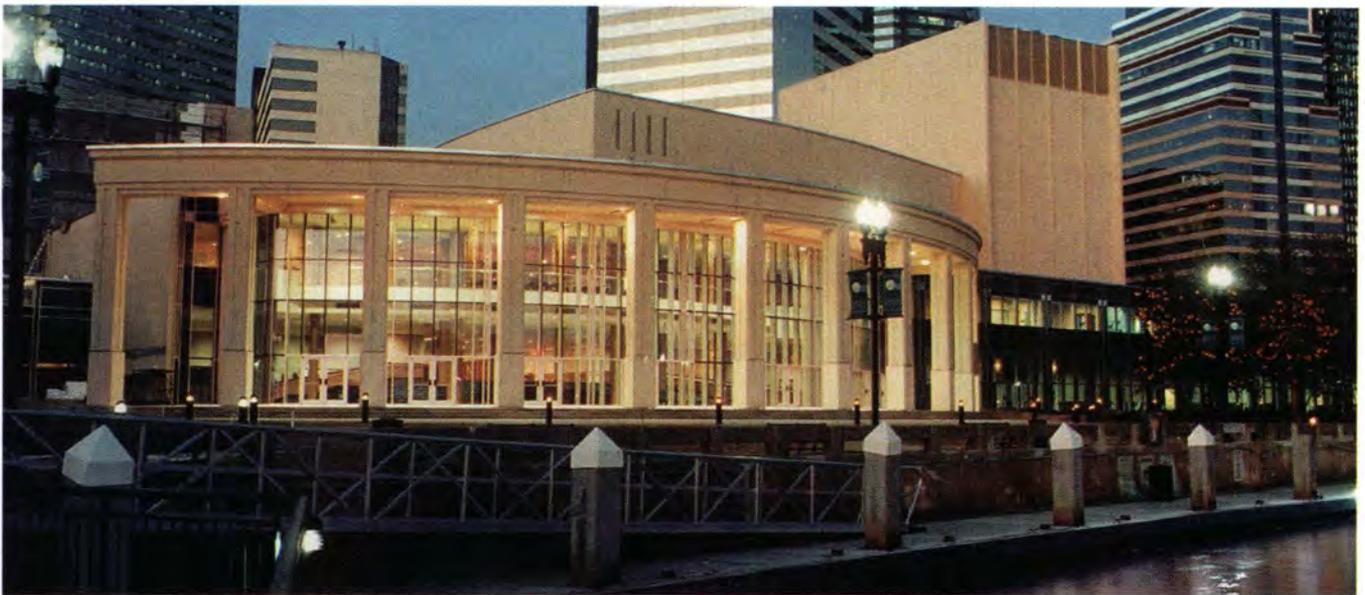
Fig. 1. The new \$32 million Times-Union Center for the Performing Arts in Jacksonville, Florida, includes a \$10.6 million concert hall (foreground) consisting of an all-precast concrete structure, including loadbearing acoustical walls for the theater.

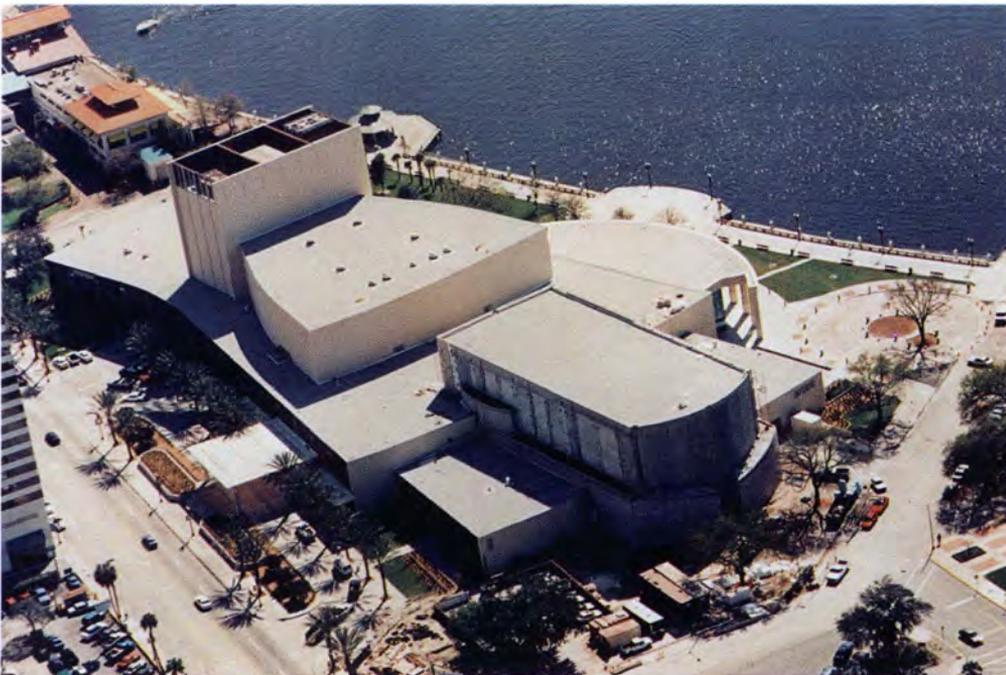
Fig. 2. Aerial view showing how the new theater (foreground) attaches to the existing two other theater sections in the building. The rear wall was removed and extended to accommodate the new three-level theater.

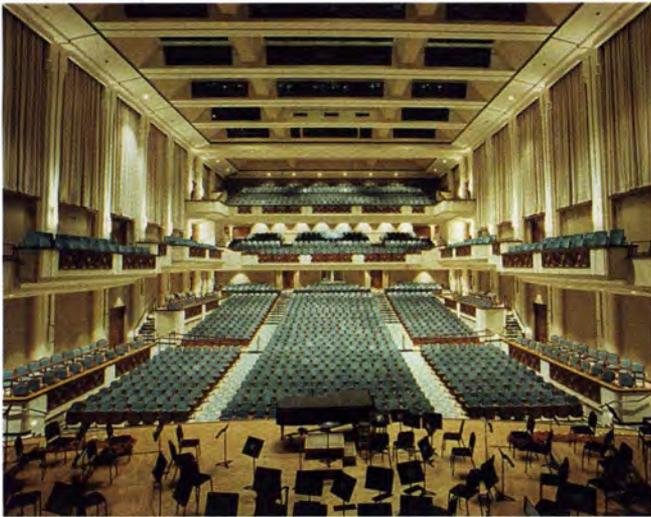
Fig. 3. The new Jacoby Symphony Hall features precast concrete walls that provide a curved and completely smooth interior surface that offers excellent acoustics. Only a low-powered public address system is used for lectures, with no enhancements needed for performances.

These massive panels not only provided structural supports but their interior surfaces were curved and finished with such a high degree of quality that no additional treatments for acoustics or aesthetics were required (see Figs. 3 and 4). But there were major challenges involved in designing and erecting these panels and the other precast concrete components that make the new three-theater complex such a success.

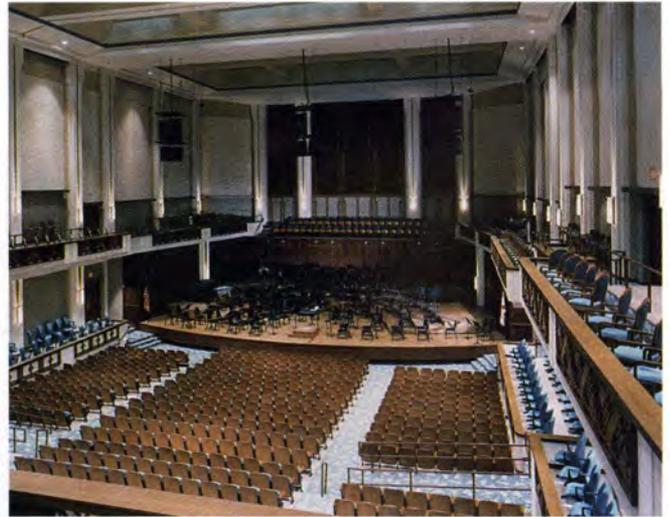
Fig. 4. Designing the precast wall panels that provide the loadbearing and acoustical needs for the Jacoby Hall was complicated by the step-down format that places the stage at the lowest point. The wide panels featured a similar step-down style that had zero tolerance for erection.

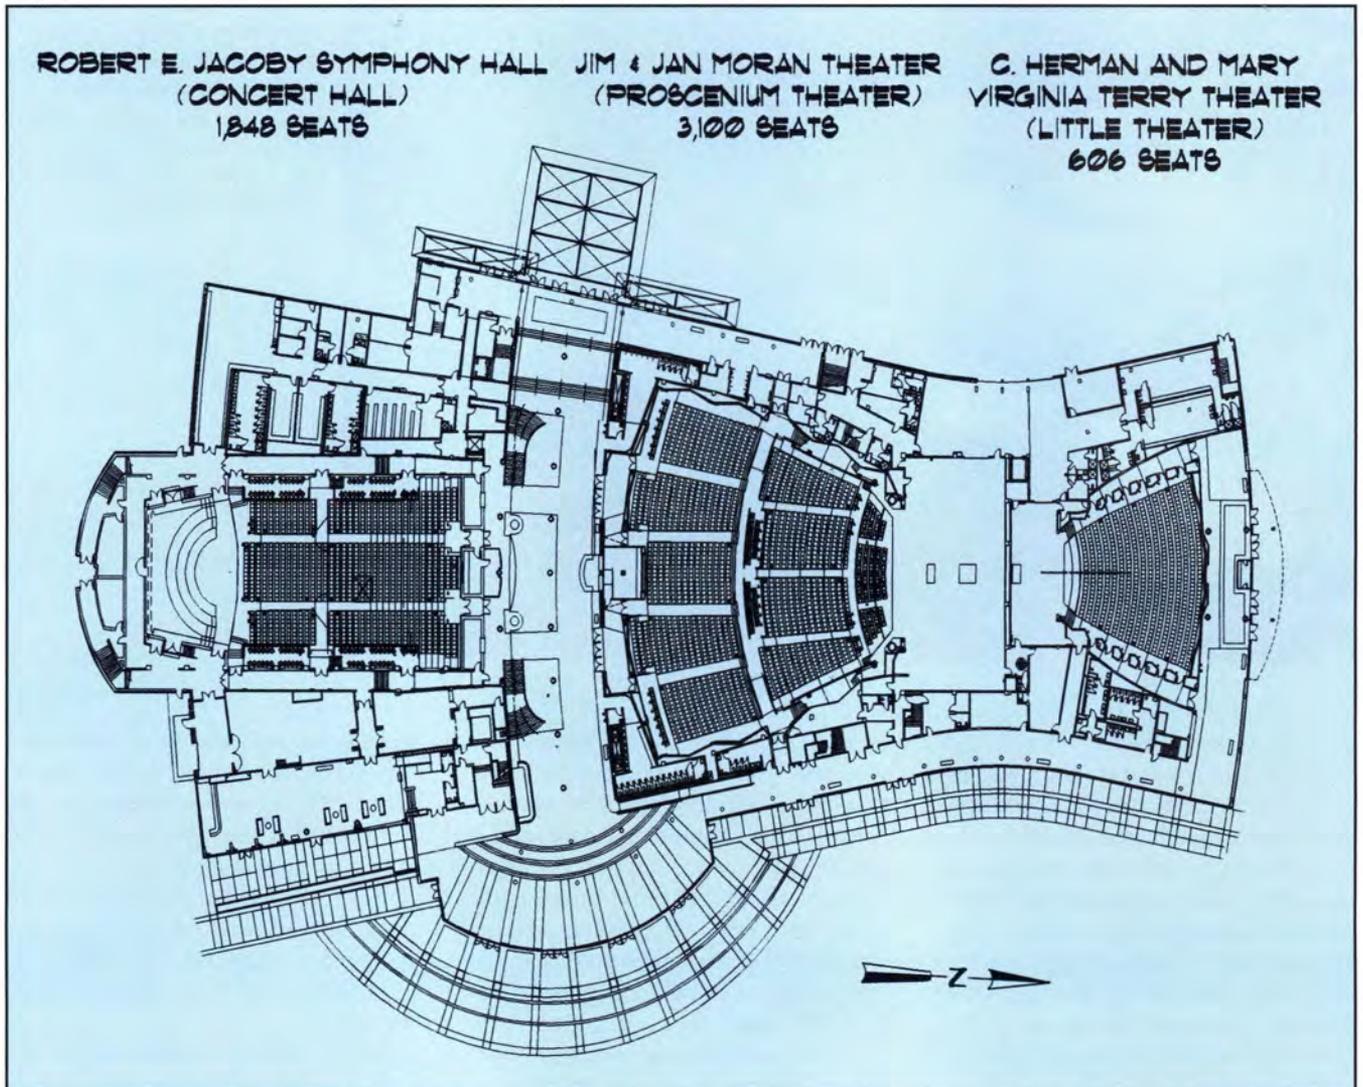
Fig. 5. Floor plan showing how the new construction (left) connects to the existing building. The structure was removed in the lobby of the Moran Theater (center) with new construction added to the left.

cility in order to build an entirely new complex. But after lengthy deliberations, they decided instead to upgrade the two existing theaters and add a new 37,000 sq ft (3437 m²) concert hall with seating for 1848 on three levels. The new plan called for a wedge-shaped section to be removed from the end of the structure and the new concert hall added there, reconnecting to the offices and existing stages on either side of this space (see Figs. 5 and 6).

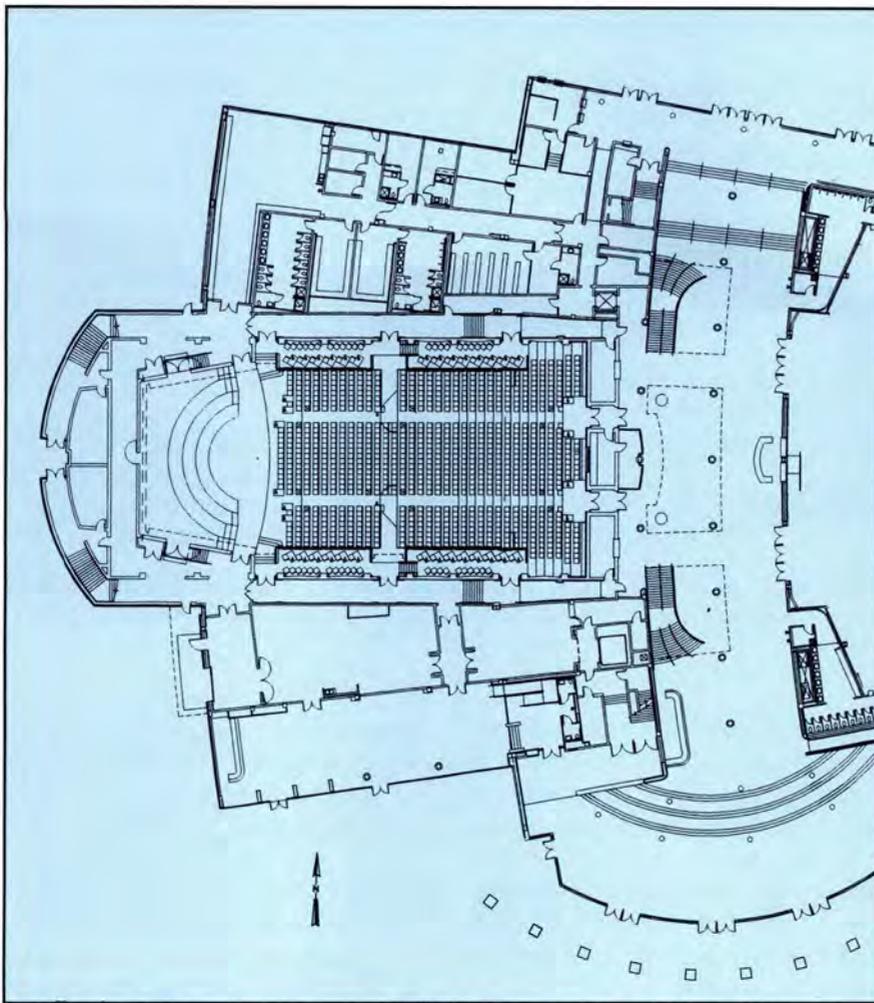
Fig. 6. The theater is designed in a long, narrow format to enhance acoustics. The new theater and office addition fits onto the original building (far right).

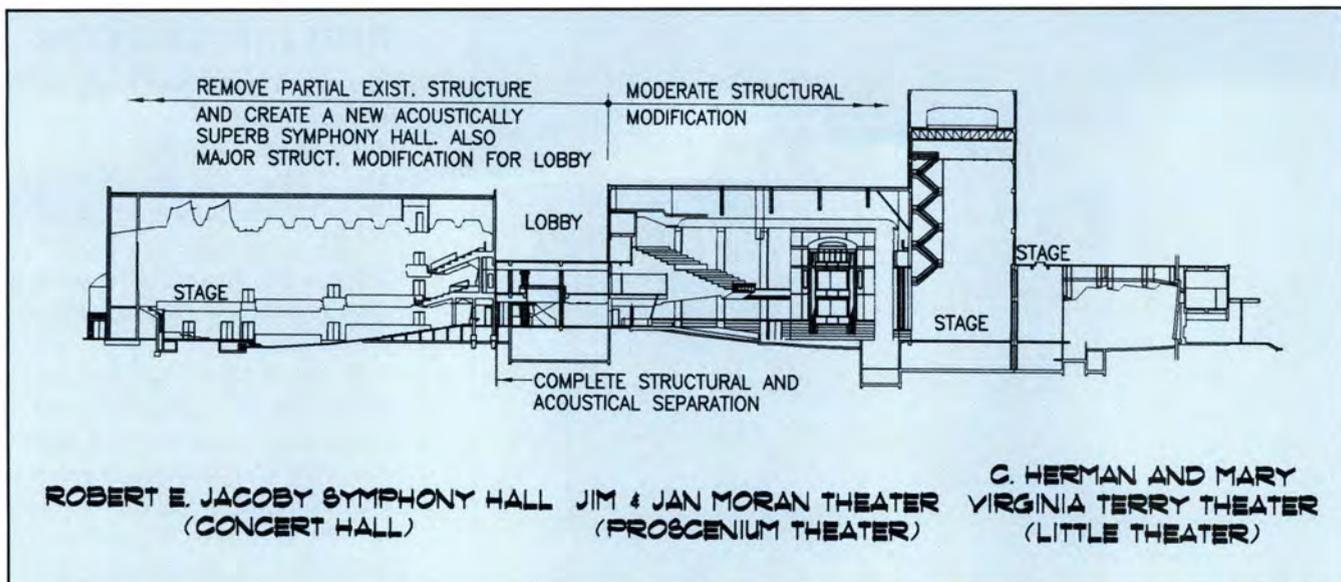
Fig. 7. Longitudinal section showing the grade levels and heights for the new and old structures. Note the two balconies added to the new section at left, which cantilever off the rear wall.

box seats along the sides of the theater, plus two concrete balconies cantilevered and supported off the rear precast concrete walls. These structures had to be designed with post-tensioned components due to the restricted headroom (see Fig. 7).

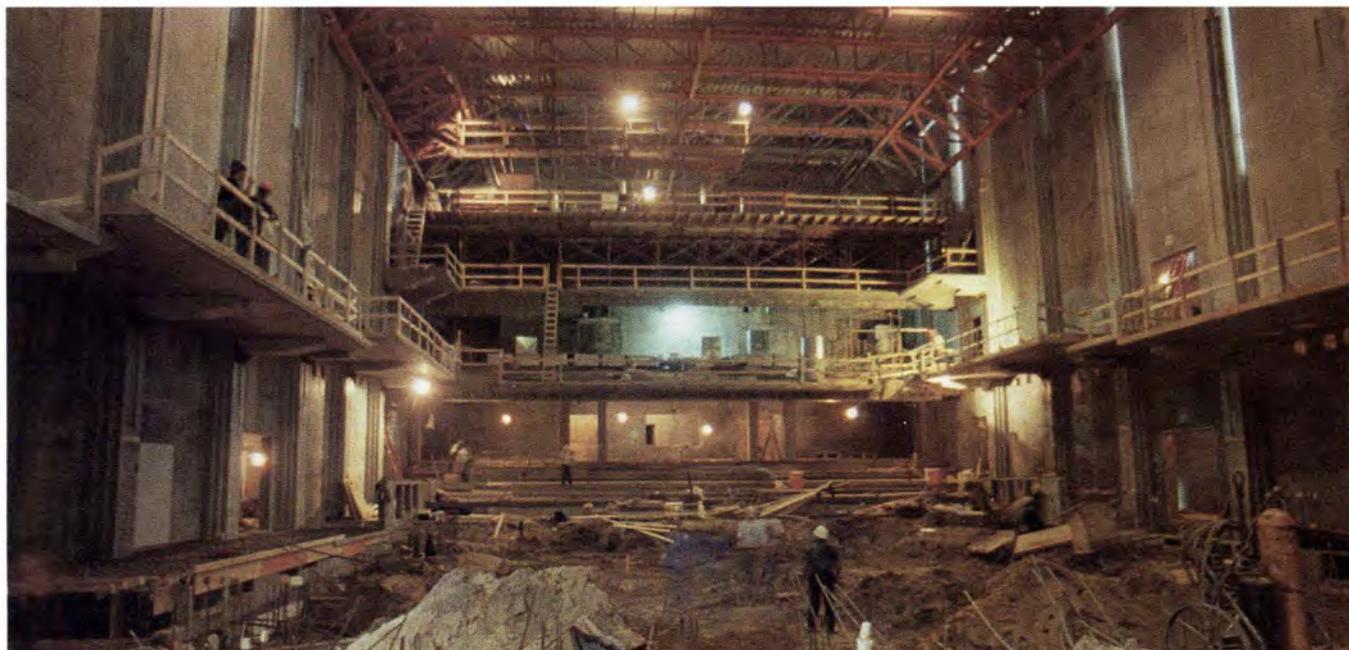
Fig. 8. Using precast concrete panels allowed the new theater to be enclosed much faster than would have been possible with other systems. It also provided the strength and thin profiles required to add two balconies into the space and reach the necessary seating requirement.

Constraints at the job site itself proved challenging and required careful consideration, especially in preparation and determination of crane locations. The building is situated on an old shipping channel of the St. Johns River that is filled with approximately 70 ft (21.3 m) of silt. The rear wall of the balcony area for the theater, which would be subject to tremendous lift, was to be located in this area (see Fig. 8). To overcome this, tension piles were integrated with the precast wall panels.

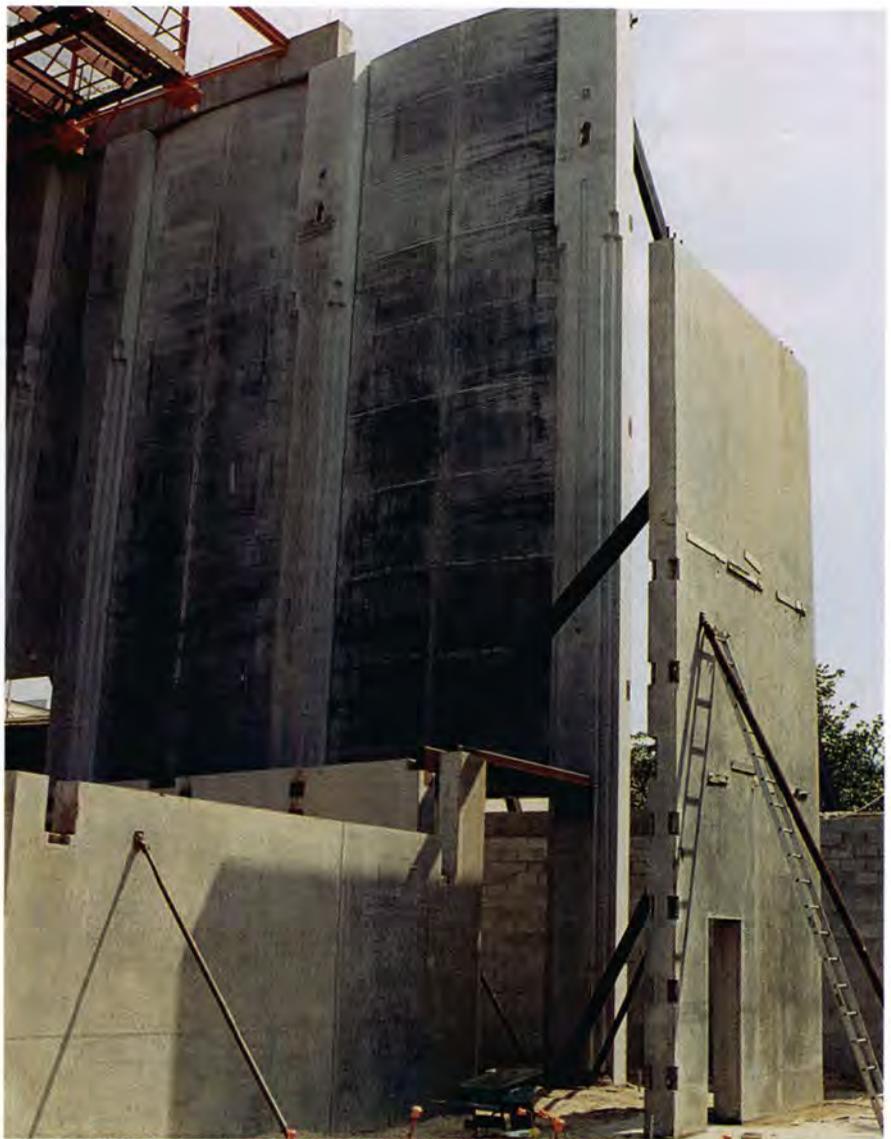
Fig. 9. The precast structure comprises a variety of components, including loadbearing panels that were curved on the interior for proper acoustics and flat on the exterior. These exterior walls were furred out and clad with drywall to serve as the corridor outside the theater.

The precast components were cast with custom-made steel forms and were so finely finished that they were simply painted with no other finishing touches added. In fact, the finish was so smooth that when the painters conducted adhesion “pull” tests on sample panels, they found that the paint would not adhere to the panels because of their smoothness. The painters ultimately had to give the panels a light acid-etching to allow the paint to adhere. The exterior sides of these panels were cast flat and were furred out and hung with drywall to act as the inside wall of the corridor running outside the theater area (see Fig. 9).

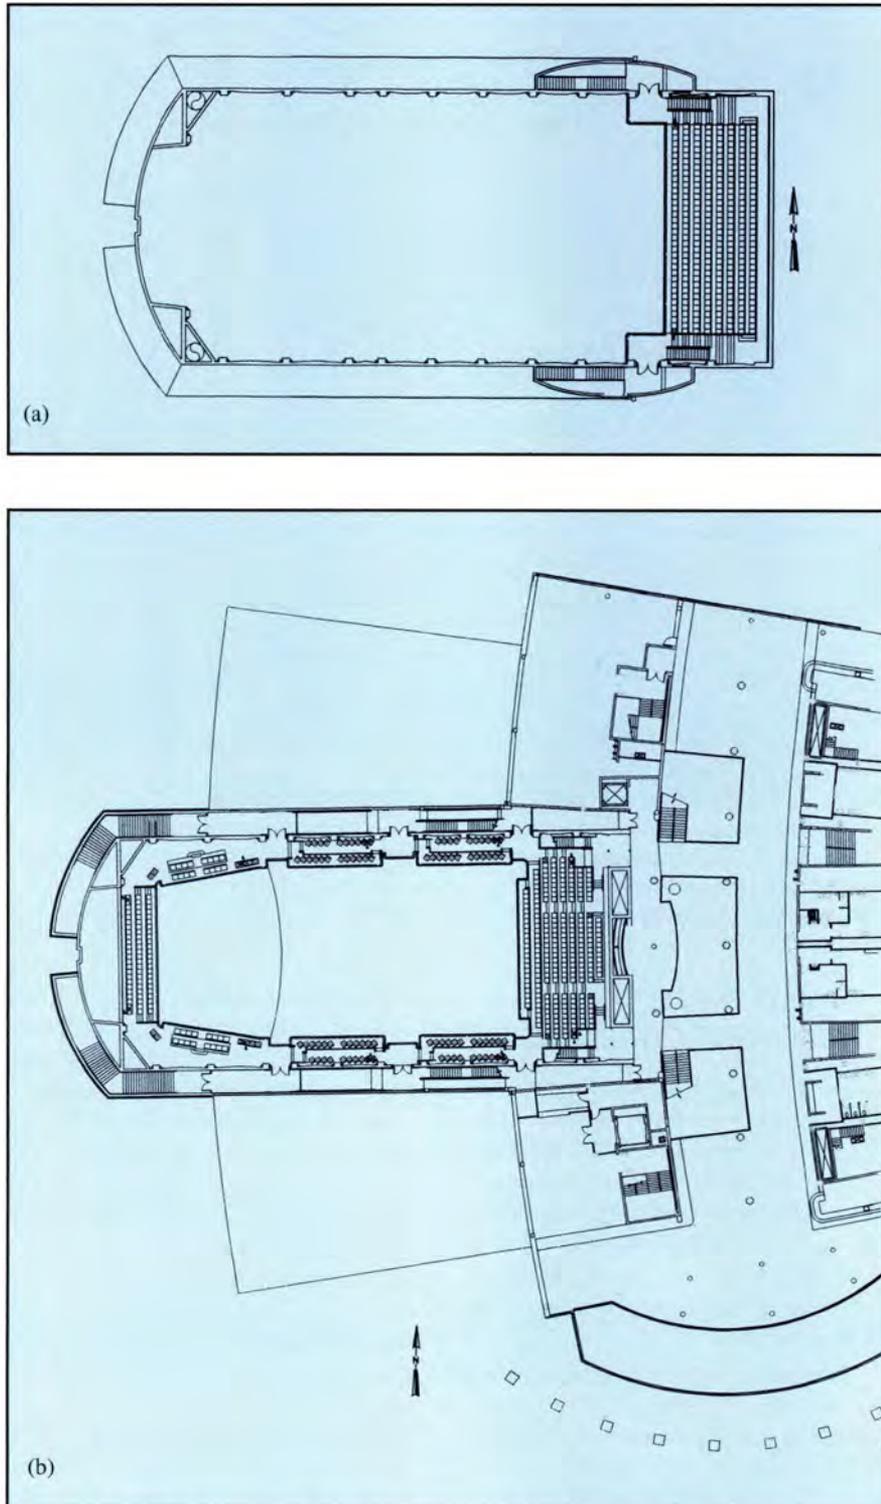
Fig. 10. These drawings show how the upper (top) and lower (bottom) balcony structures align within the theater.

Another key challenge came in adding the two balconies required to meet the desired seat count (see Figs. 10a and 10b). Due to the limited headroom, designers used cantilevered post-tensioned concrete solid slabs to provide the 25 ft (7.62 m) long balconies (see Fig. 11). These slabs were supported with high tension tendons through precast columns and beams (Figs. 12, 13 and 14). The post-tensioning tendons were cast into the cantilever beams and threaded through sleeves in the precast columns and tensioned from the back side of the column prior to placement of the flooring units.

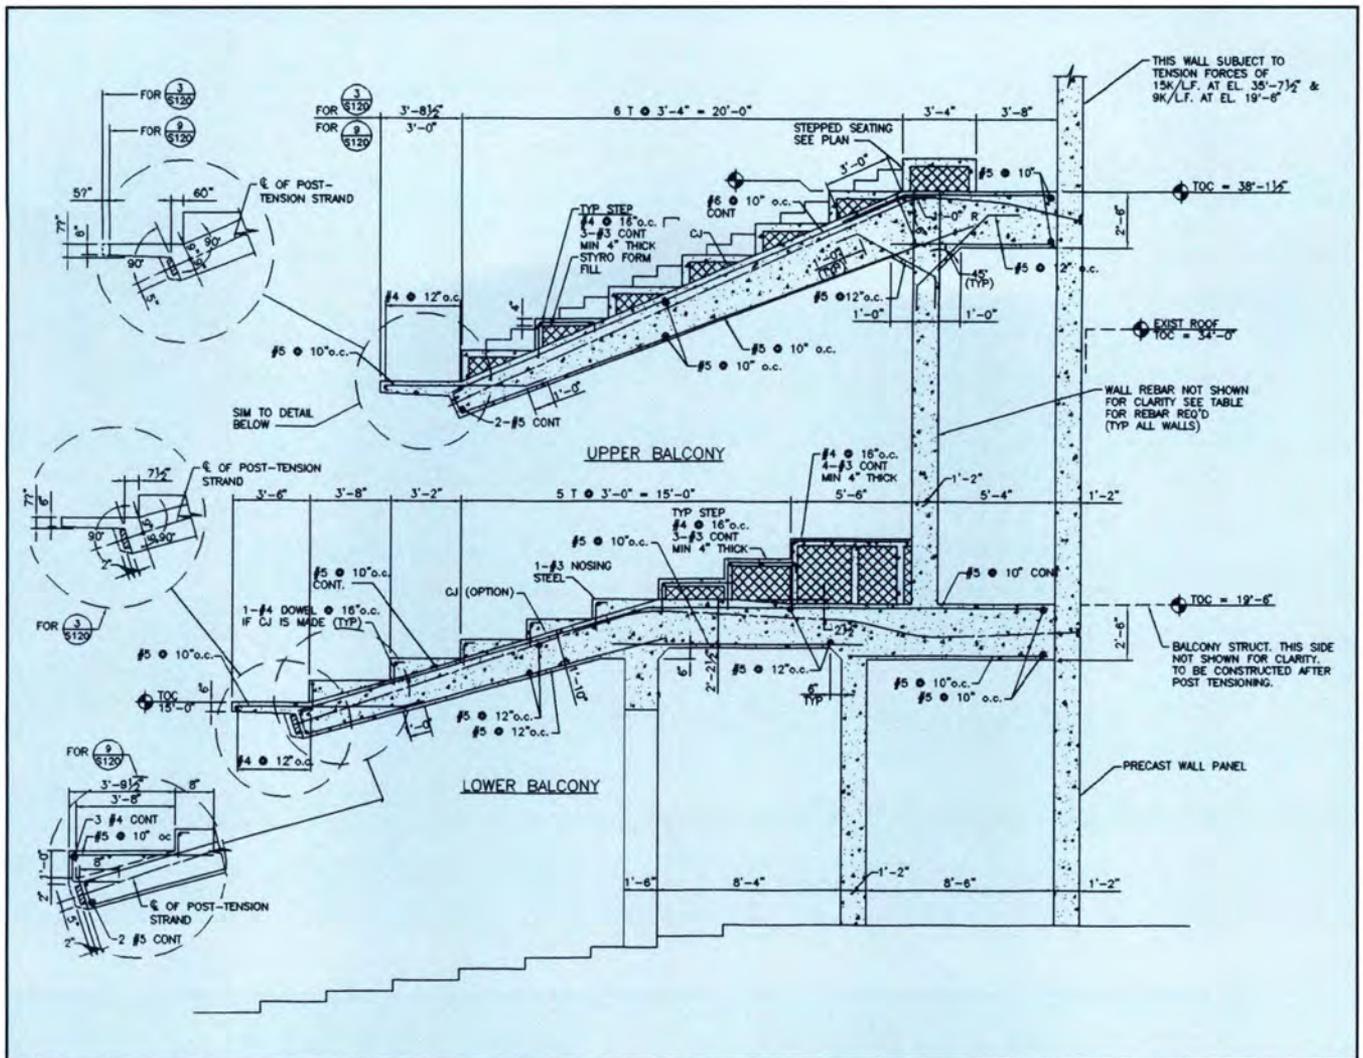
Fig. 11. Sectional drawing showing how the balconies were cantilevered off the rear wall of the theater.

These slabs varied in thickness from 18 in. (457 mm) at the free end to 30 in. (762 mm) at their fixed point. Due to the long overhang and the short anchoring distance from both balconies, the back wall at the north end of the

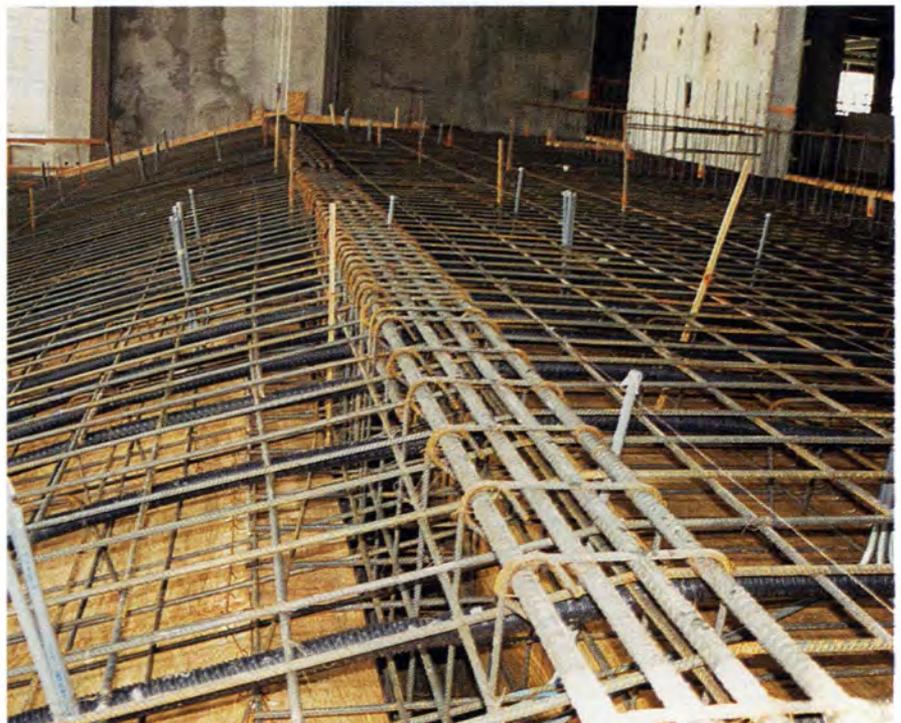
Fig. 12. Post-tensioning tendons and mild steel reinforcement for balconies.

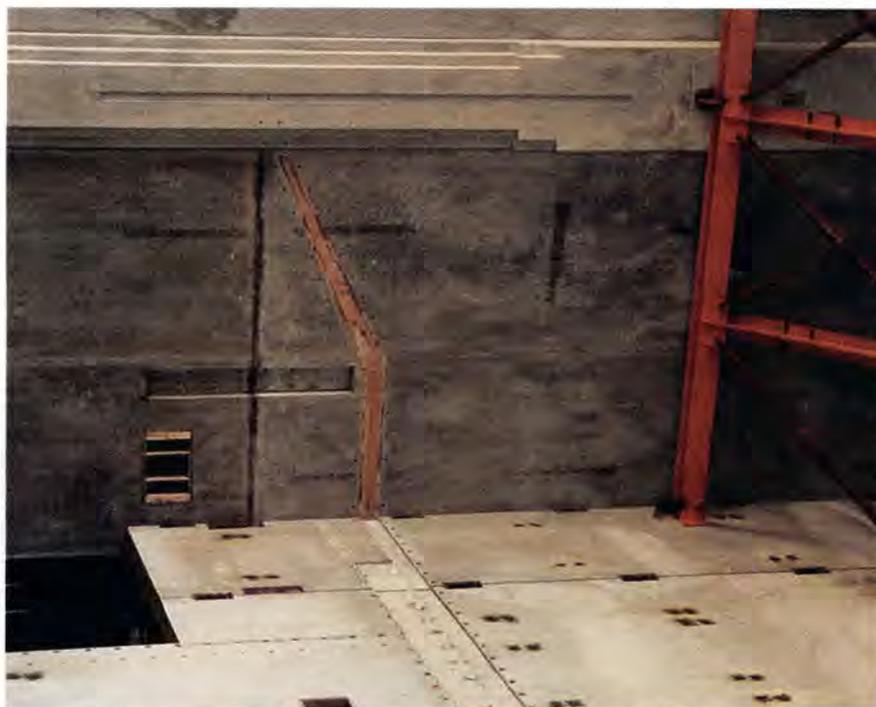
Fig. 14. The balcony slabs were cantilevered and connected to the back wall of the theater, which was also made of precast concrete.

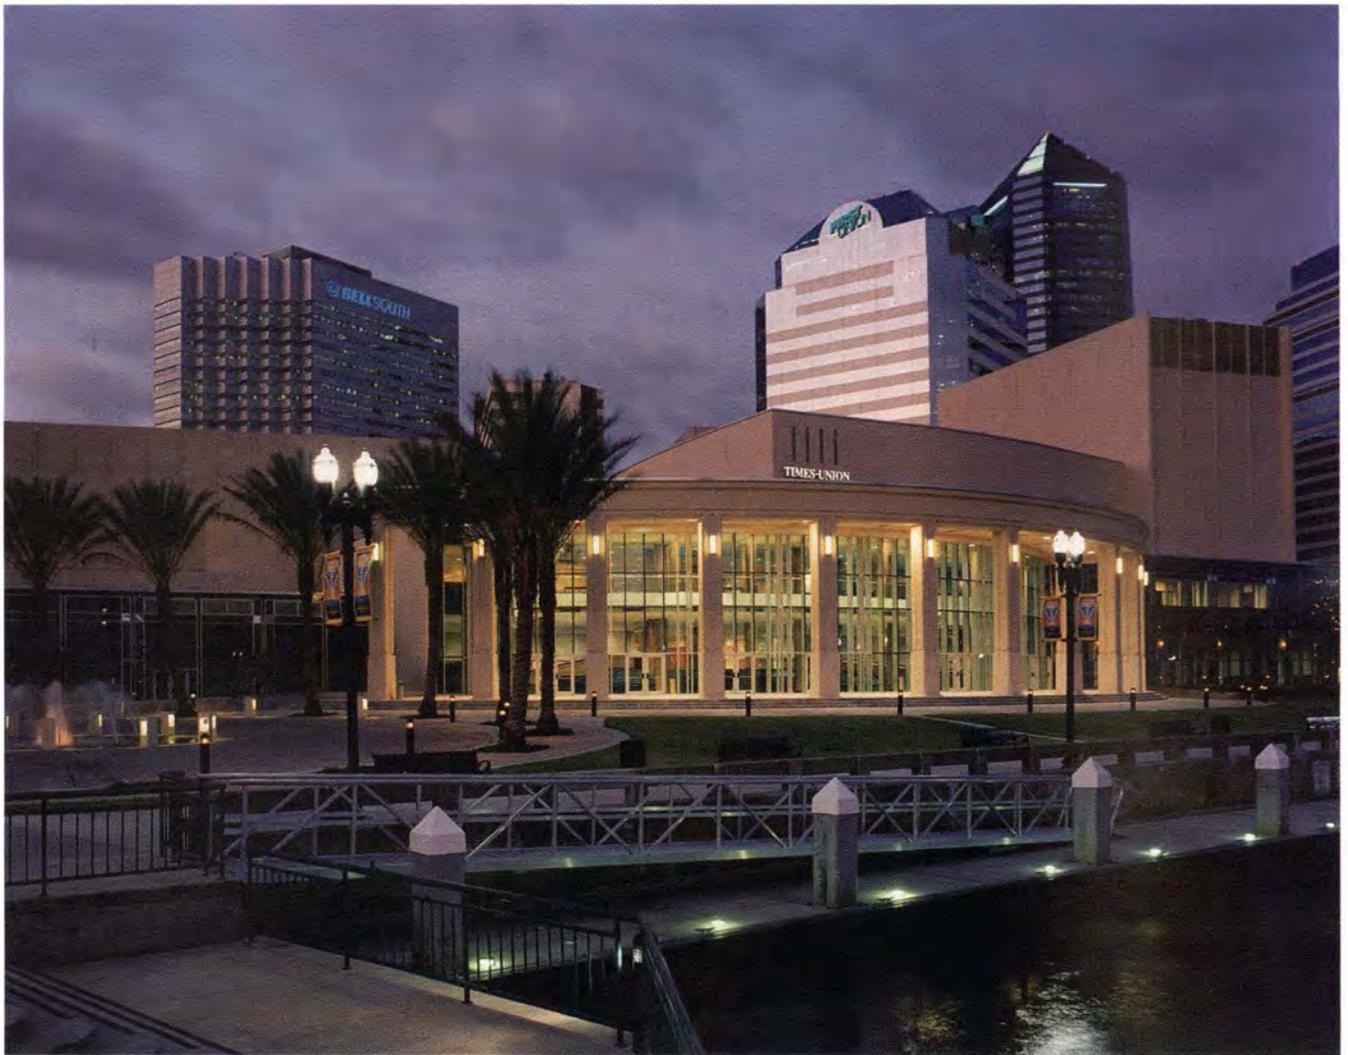
Fig. 15. Large glass areas set into the precast concrete structure of the new theater section in the center offer a dramatic and eye-catching view at night time.

Because the project architect had designed the original theater, matching the exteriors was simplified. The existing structure featured a yellow-brick exterior that the designers decided to complement rather than attempt to match. This was accomplished with an exterior finish painted in the same buff color as the original building. The combination of two finishes in the same color proved to be a success in matching the two different structures (see Fig. 15).
