# Lateral capacity and repair of corrosion-damaged pile bents, part 2: Numeric modeling for strength restoration

Gray Mullins, Rajan Sen, Michael Stokes, and Joseph Scott

This paper appears in *PCI Journal* (ISSN 0887-9672) V. 70, No. 4, July–August 2025, and can be found at <https://doi.org/10.15554/pcij70.4-03>. *PCI Journal* is published bimonthly by the Precast/Prestressed Concrete Institute, 8770 W. Bryn Mawr Ave., Suite 1150, Chicago, IL 60631. Copyright © 2025, Precast/Prestressed Concrete Institute.

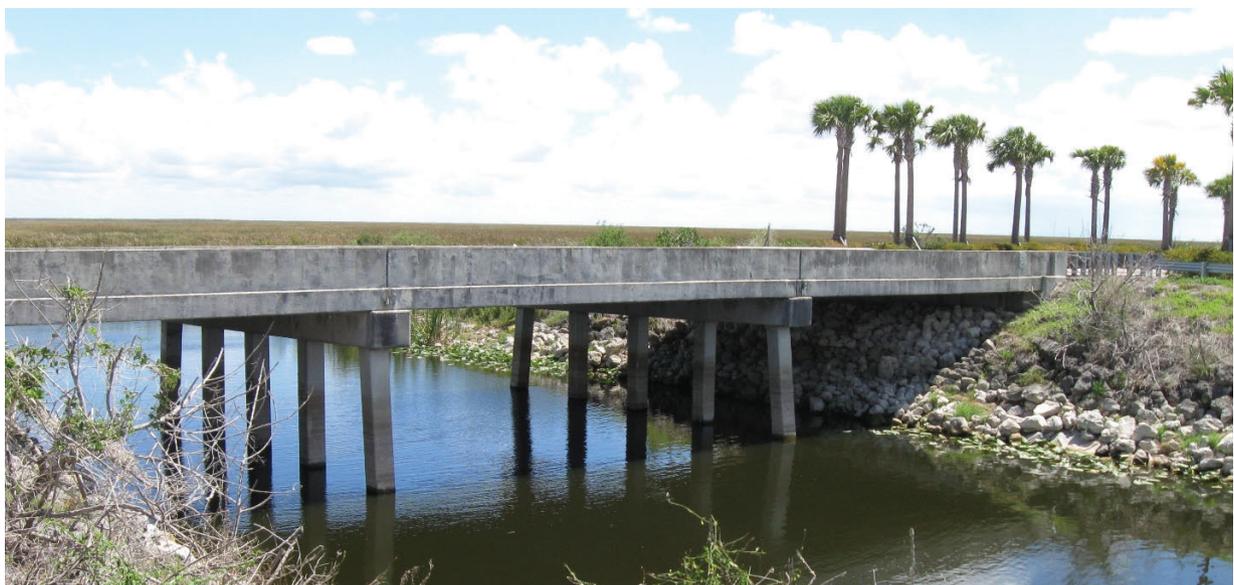
**Figure 1.** Typical pile bent built in the 1970s. This example is from the Alligator Alley stretch of southbound Interstate 75 in southern Florida between Naples and Fort Lauderdale.

a pile bent (**Fig. 1**). Pile bents are described as driven piles aligned in rows that extend up from the bearing soil to the underside of the bridge at the location of a pile cap. The pile cap is cast around the piles to form a support beam for the superstructure elements. Pile-bent-type piers are inexpensive to build, but they are vulnerable to splash-zone-related corrosion damage due to tidal-fluctuation-induced cycles of wetting and drying.

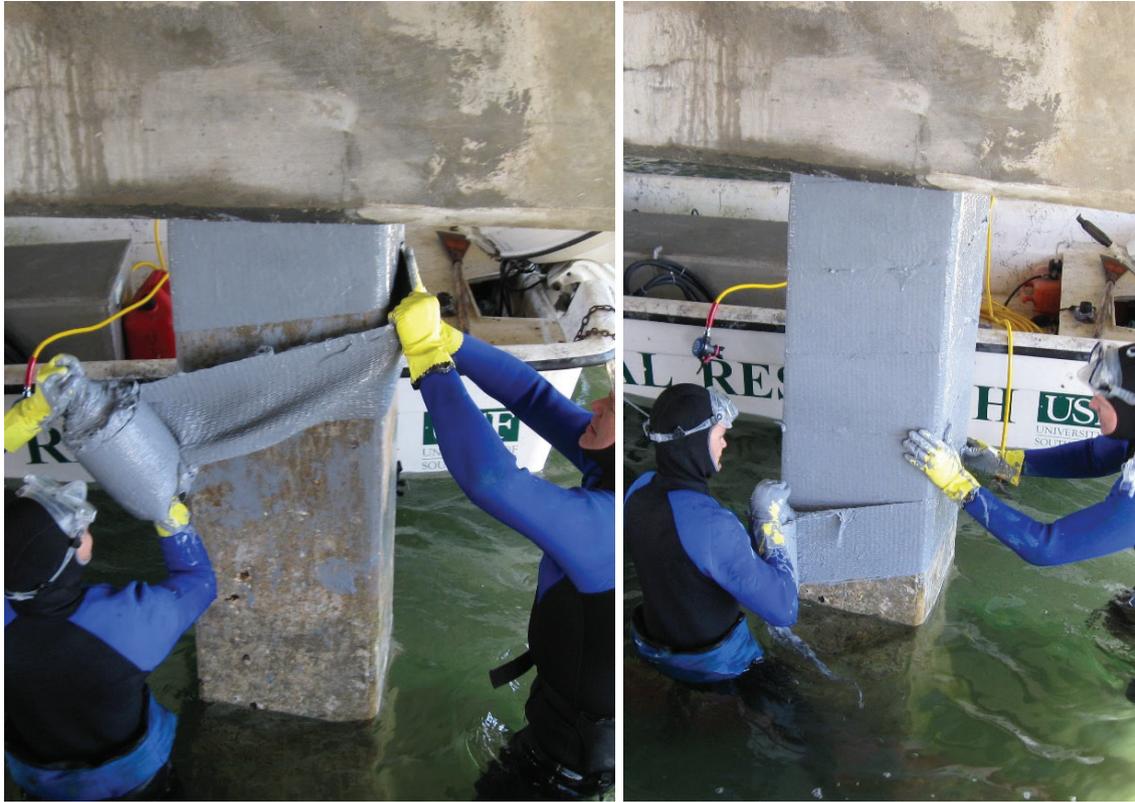
**Figure 2.** Fiber-reinforced polymer confinement applied from cap to mudline to arrest corrosion-induced crack growth.

ment. The added benefit of concrete confinement from CFRP repairs was not considered in the numerical models presented herein because the software assumed that normal confinement was provided and did not provide a means to simulate losses in spiral reinforcement. Hence, the transversely oriented fibers were assumed to replace the missing steel spiral reinforcement; however, the nonlinear finite element software provides an additional confinement option and can include the associated strength benefits in cases where CFRP confinement exceeds the original stirrup strength. Design for lost confinement from corroded stirrups should simply provide a strength in carbon fibers that is equivalent to the strength of the original transverse steel stirrups. Assumption of full steel loss is conservative, and most FRP wrap repairs include at least one layer of a spiral layup process like the one in Fig. 2.

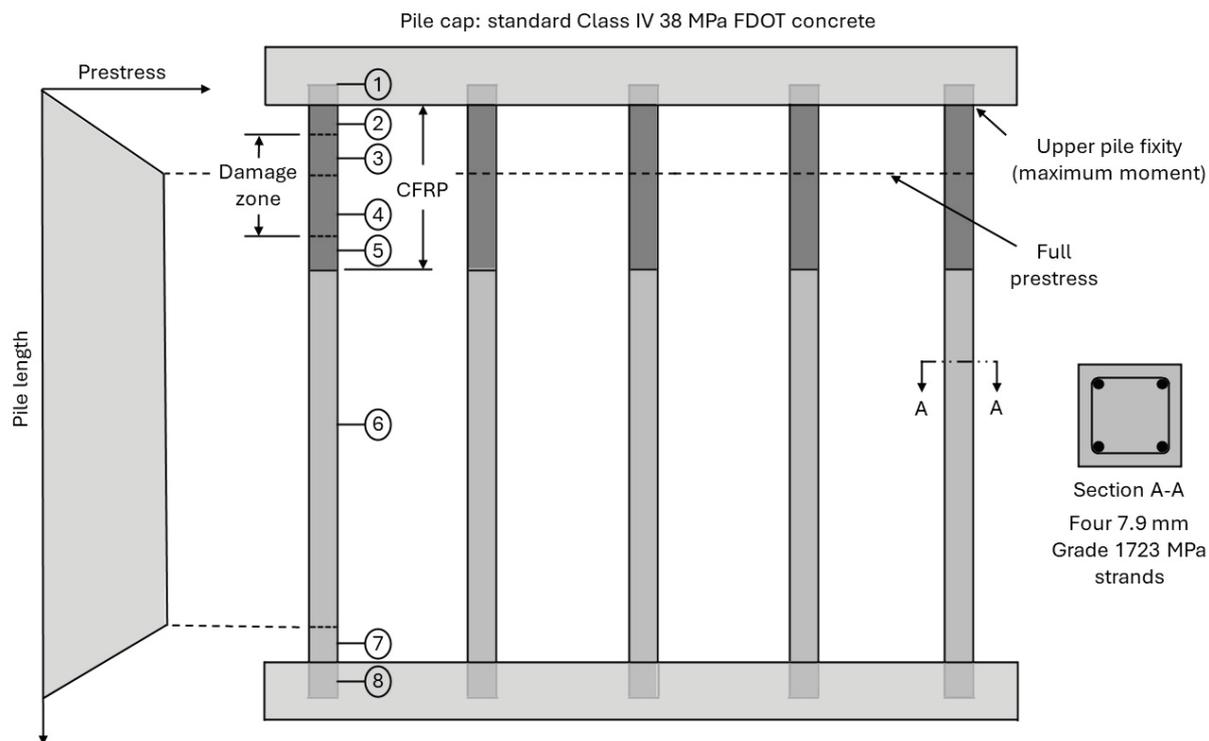
**Figure 3.** Pile segments used in numerical models to account for changes in concrete and effective prestress. Note: CFRP = carbon-fiber-reinforced polymer; FDOT = Florida Department of Transportation.

All pile-bent components were included in the numerical models down to the floor-level beam so that a direct comparison to laboratory load responses could be made. For the numerical model, each pile was broken into segments to represent variations in concrete strength, effective prestress, and area of the steel strands along the length of the pile.

concrete strength variations from the top segment (segment 1) through the bottom segment (segment 8) in the piles with 0% steel loss (controls). Segment 5 was included to accommodate the CFRP shear lap length required to develop the carbon fibers (discussed later).

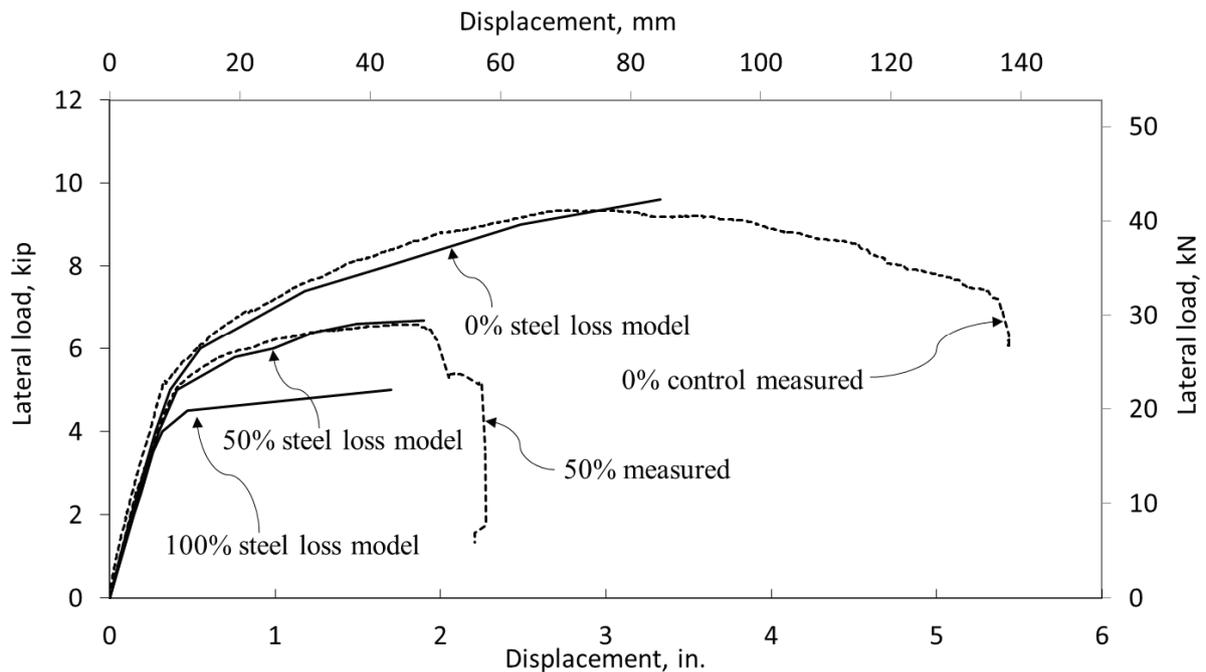
**Figure 4.** Modeled versus measured pile bent response to lateral loading. 1 mm = 0.0394 in.; 1 MPa = 0.145 ksi.

In addition, a model was run with 99.9% steel loss (called 100% in Fig. 4). The 0.1% remaining steel was required to satisfy software input parameters, but it provided no appreciable contribution to the capacity. The service load (44 kN [9.9 kip] per pile) effectively simulated approximately 28% of the original prestress force offered by the uncorroded strands (1.6 MPa [232 psi]) and maintained some lateral capacity even when all steel was missing.

The calibrated model agreement (Fig. 4) provided the confidence to proceed with the assessment of a viable CFRP repair model of the corrosion-damaged pile bent, but first, prelim-

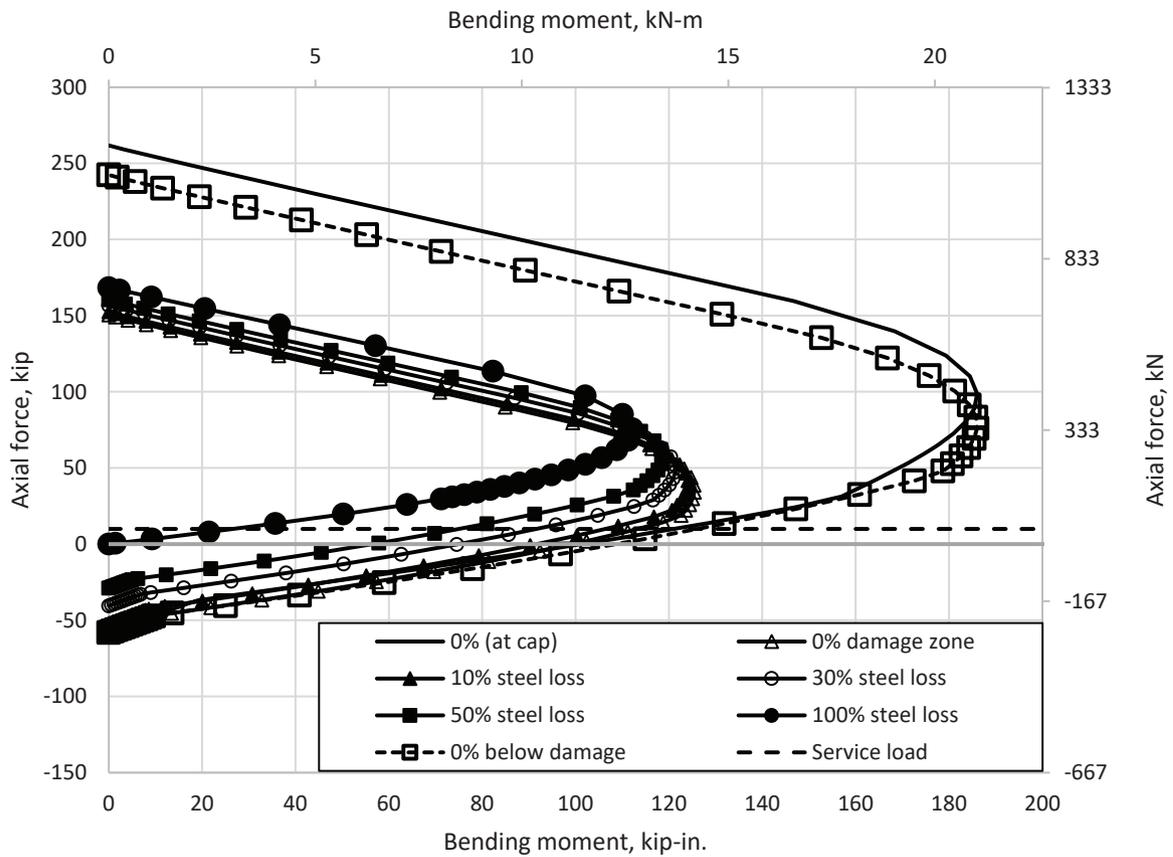
**Figure 5.** Interaction diagram for all portions of the piles where changes in steel area and concrete strength affected capacity.

At 100% steel loss, no appreciable bending resistance can be developed unless axial load is applied to offset the tensile stresses (Fig. 5). As expected, at lower bending stresses, a loss in prestress results in an increase in axial resistance. At the service-level axial load, the bending resistance in the undamaged region just below the cap (with reduced effective prestress) is similar to that below the damage zone (full effective prestress). Both of those regions had the higher-strength concrete, and both retained 100% steel cross sections in all tests. In fact, it is likely that the modeled bending capacity just below the cap will never be affected by the loss in effective prestress at typical axial load levels for bridge piers. **Table 3** lists the bending resistance from Fig. 5 for all modeled pile segments at the service-level axial load.

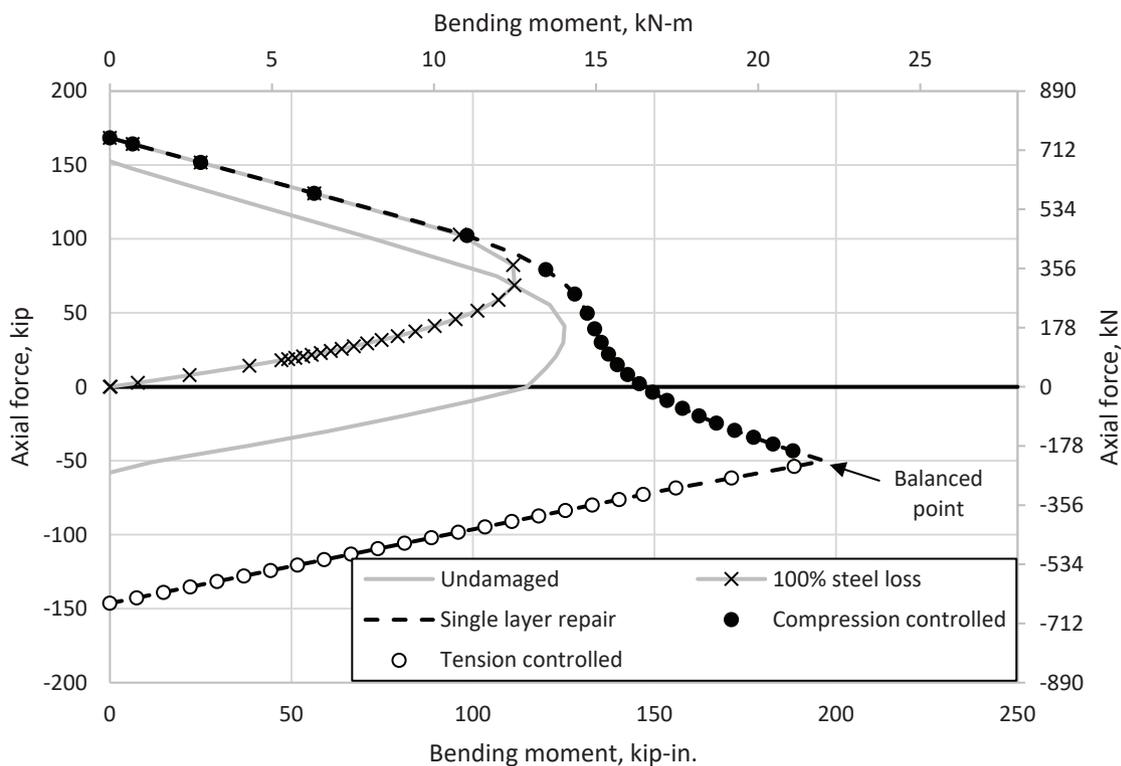
**Figure 6.** Interaction diagrams for an undamaged section, a section with 100% steel loss, and a section with 100% steel loss that has been repaired with one layer of carbon-fiber-reinforced polymer.

**Figure 6** shows the interaction diagrams for an undamaged cross section, a damaged cross section with 100% steel loss, and a damaged cross section repaired with one layer of CFRP. With 100% steel loss and associated loss in concrete precompression, the damaged cross section gains a slight increase in axial compressive capacity while losing all axial tensile capacity from the steel. With the addition of one layer of CFRP, the repaired interaction diagram fully envelops the undamaged diagram, thereby showing that at any axial force, the bending capacity of the repaired section meets or exceeds that of an undamaged pile. At zero axial force, the pure bending capacity is increased to 16.6 kN m (147 kip in.), which is approximately 28% higher than the pure bending capacity of an undamaged cross section. Also, the characteristically high tensile strength of the CFRP increases the axial tensile capacity by 152% and moves the balanced point on the interaction diagram (the point at which concrete crushes and CFRP ruptures) below the x axis into the region of net axial tension. Once these calculations gave confidence that one longitudinal layer of CFRP would be sufficient to fully restore the capacity of the undamaged pile, finite element modeling of this repair

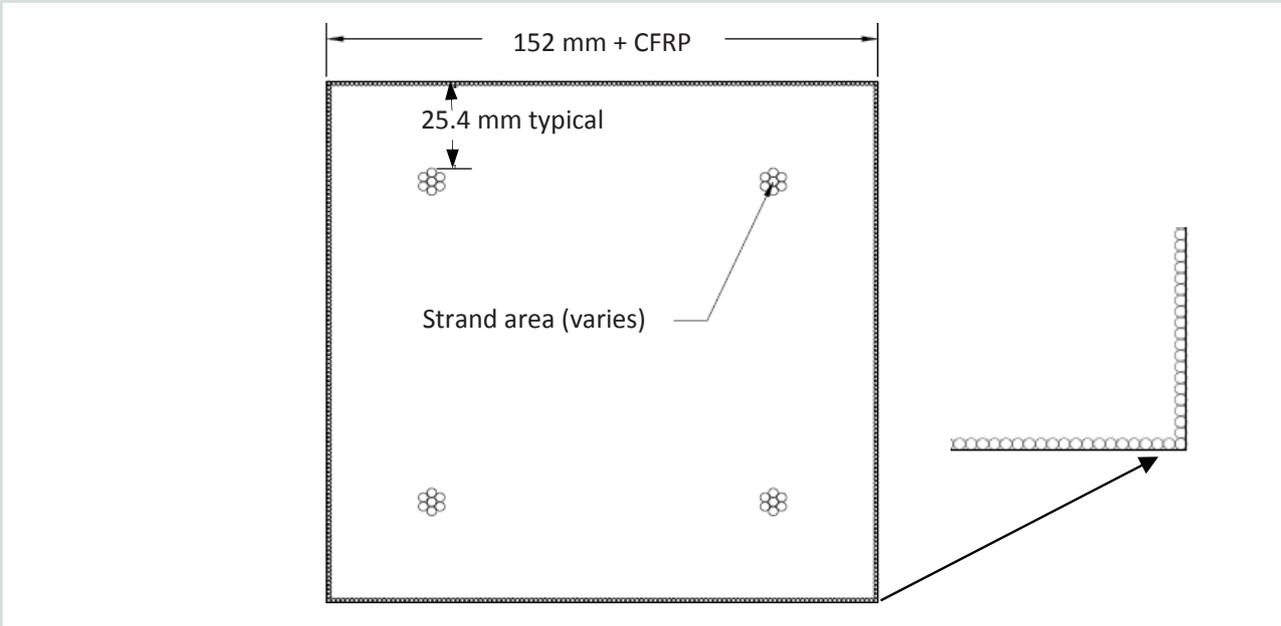
**Figure 7.** Modeled pile cross section with carbon-fiber-reinforced polymer (CFRP) wrap. Note: 1 mm = 0.0394 in.

CFRP was modeled to cover segments 2 through 5 (Table 1), and the strand area in Fig. 7 varied. Segments 2 and 5 on either side of the damage zone provided bonded development length for the carbon fibers and retained 100% of the steel section. Segments 3 and 4, representing the damage zone, had no steel.

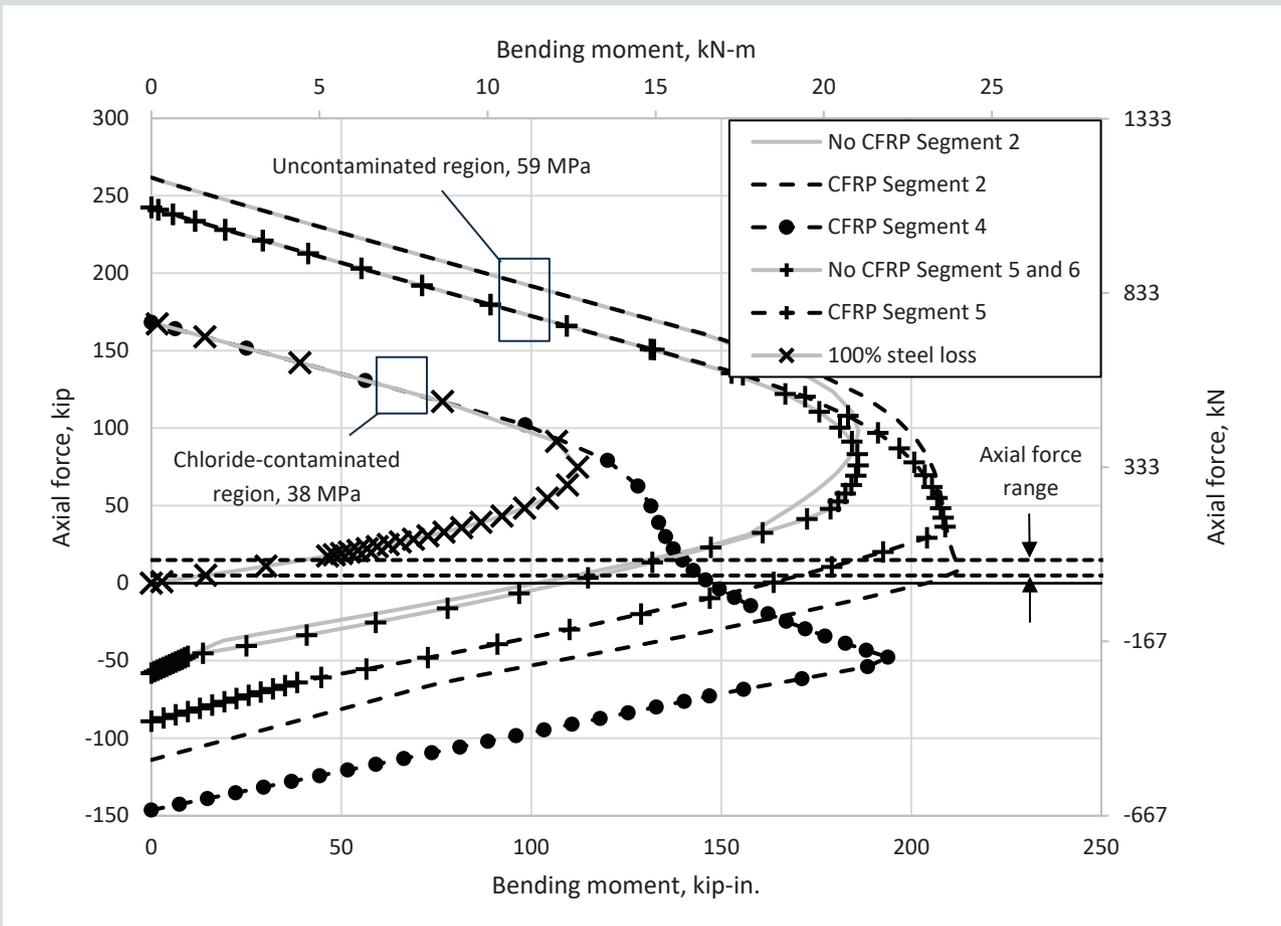
**Figure 8.** Interaction diagrams for pile segments with and without carbon-fiber-reinforced polymer (CFRP) repair material.

- 100% steel loss in the damage zone (segment 4)
- the undamaged region below the cap (segment 2)
- the undamaged regions below the damage zone (segment 5)

In all cases, the dashed line is the CFRP-repaired segment. Three limit states were used in the calculations to define nominal capacity:

- concrete crushing
- steel rupture
- CFRP rupture

the interaction diagram at service axial load for the CFRP-wrapped segment 2 (Fig. 8) shows bending resistance of 24 kN-m (210 kip-in.), an upper limit must be applied at the pile-to-pile cap interface that is no greater than the bending resistance of the undamaged, unwrapped pile. The model in this case assumed the strength of CFRP-repaired segment 2 extended into the cap and therefore overpredicted the pile bending resistance at the pile-to-cap interface.

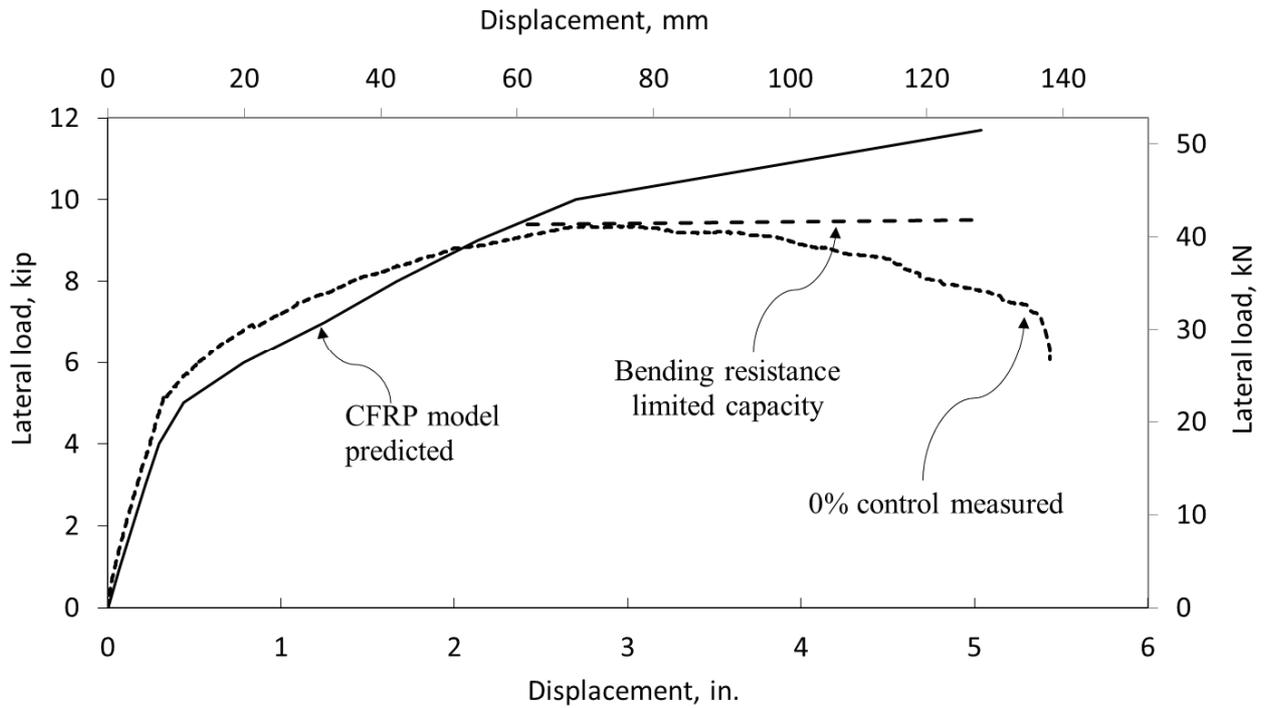
Figure 9. Model results for pile bent repaired with carbon-fiber-reinforced polymer (CFRP).

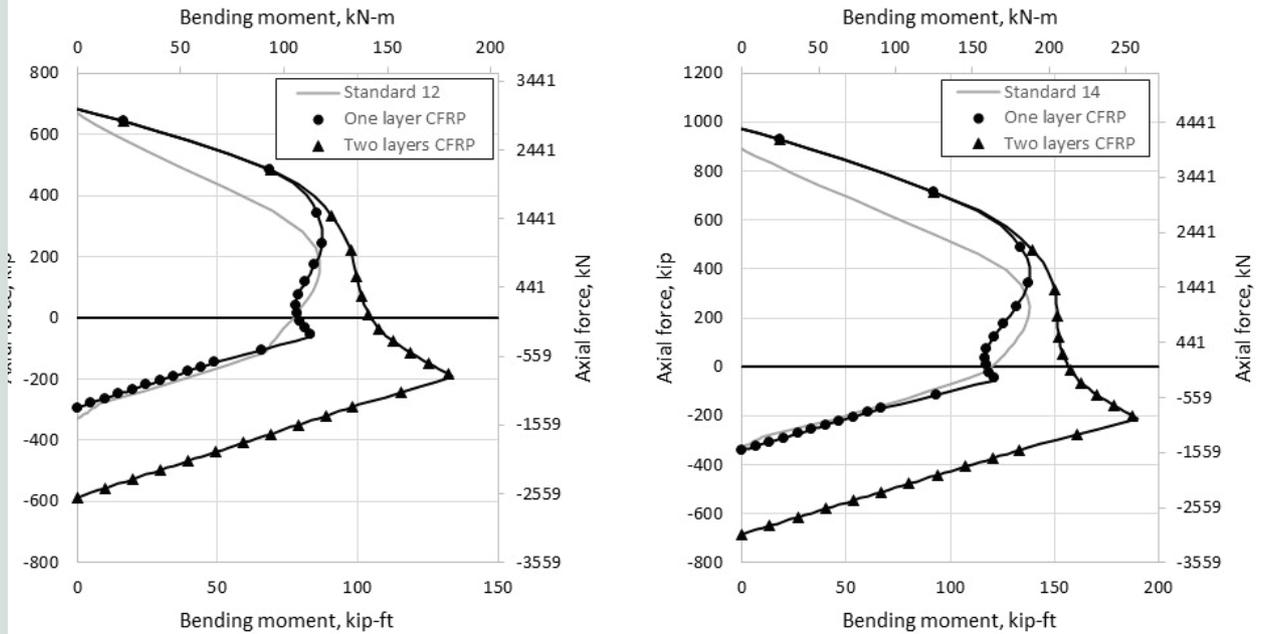
Figure 10. Interaction diagrams for carbon-fiber-reinforced polymer (CFRP) repairs of 0.3 and 0.36 m piles. Note: 1 m = 3.281 ft.

of the pile size to the moment of inertia. Figure 10 shows that one layer of longitudinally aligned, uniaxial CFRP restores almost all capacity for 0.30 and 0.35 m (1 and 1.2 ft) piles and, depending on the actual demand, may provide sufficient resistance; two layers fully envelop the undamaged interaction diagrams. For the 0.46 and 0.51 m (1.5 and 1.7 ft) piles, two

Like the model pile repair, the repair schemes in Fig. 10, 11, and 12 assume that there is no remaining prestressing steel (that is, a chloride-contaminated-zone condition), and they use the standard FDOT Class V (38 MPa [5.5 ksi]) concrete that was used in the one-third-scale testing and numerical modeling. The pile core is assumed to be compressed by a service load of 10% of ultimate axial capacity at the time of repair. Hence, the cover replacement material, which must be formed and placed before CFRP repair material is applied, would be unstressed by dead load. **Table 6**, which uses data from *Standard Specifications for Road and Bridge Construction*,<sup>12</sup> summarizes the repair schemes in Fig. 10, 11, and 12 for the same pile sizes and gives the required CFRP strength (force) per unit width of longitudinal fibers. These repairs meet or exceed the undamaged nominal capacity at any axial force (the same procedure described earlier for the one-third-scale model piles). The material is to be applied to the full perimeter of the pile sides where cover loss to spalling has been restored, which will also be discussed in part 3 of this series. Table 6 also provides the minimum number of layers using the same commercially available uniaxial carbon fiber used in the models. The computed number of required layers should be rounded up to the next integer value. No transverse confinement wrap is considered in Fig. 10, 11, or 12, but it should be included in any repair plan where the transverse FRP tensile strength is equivalent to the original steel spirals.

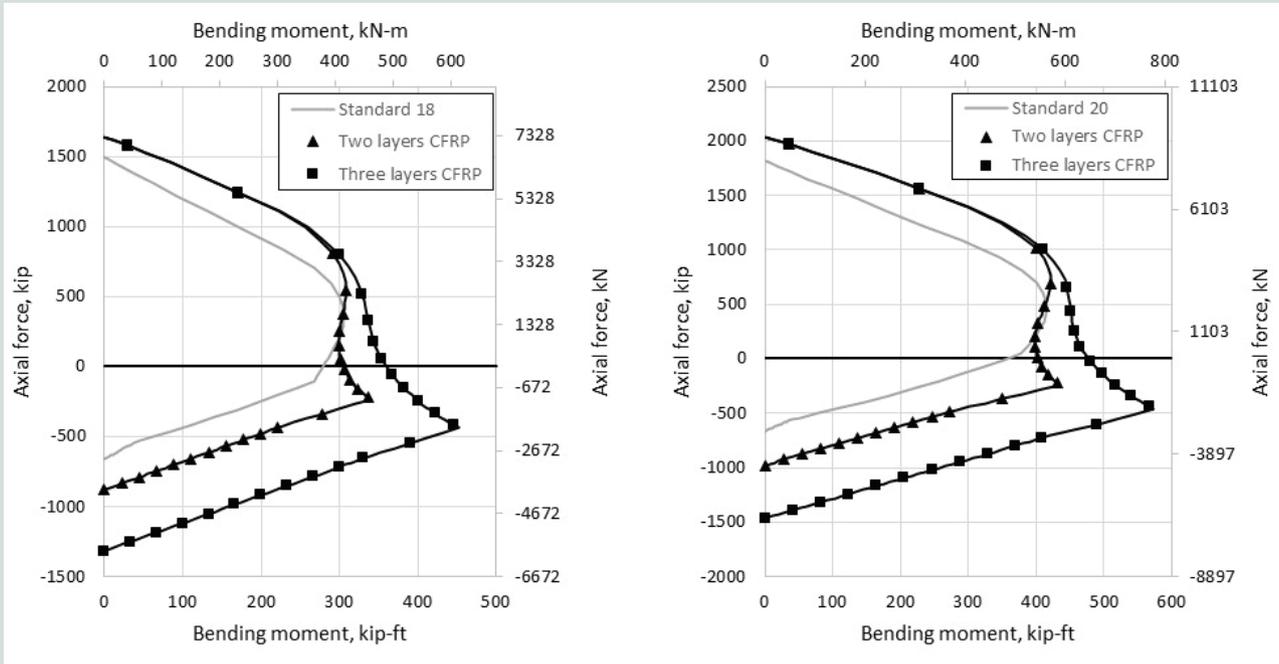
**Figure 11.** Interaction diagrams for carbon-fiber-reinforced polymer (CFRP) repairs of 0.46 and 0.51 m piles. Note: 1 m = 3.281 ft.

layers nearly restore full capacity, but using three layers is more conservative (Fig. 11). Larger pile sizes may or may not contain an internal void, which, depending on the final installation position, could fall within a damaged region. The 0.6 m (2 ft) and voided regions of a 0.76 m (2.5 ft) pile need three layers but with no conservative margin (Fig. 12). The minimum number

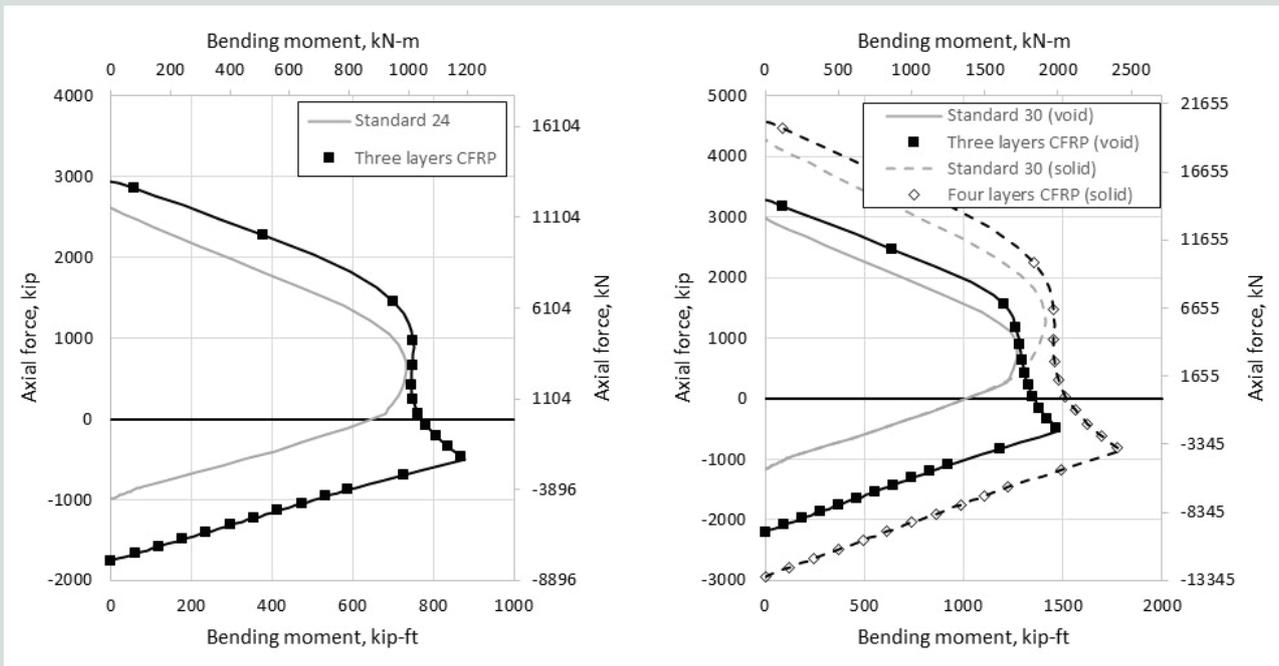
**Figure 12.** Interaction diagrams for carbon-fiber-reinforced polymer (CFRP) repairs of 0.61 and 0.76 m piles. Note: 1 m = 3.281 ft.
